# Gore District: Archaeological Appraisal

Gore District Council

May 2022

**Report No.** 306

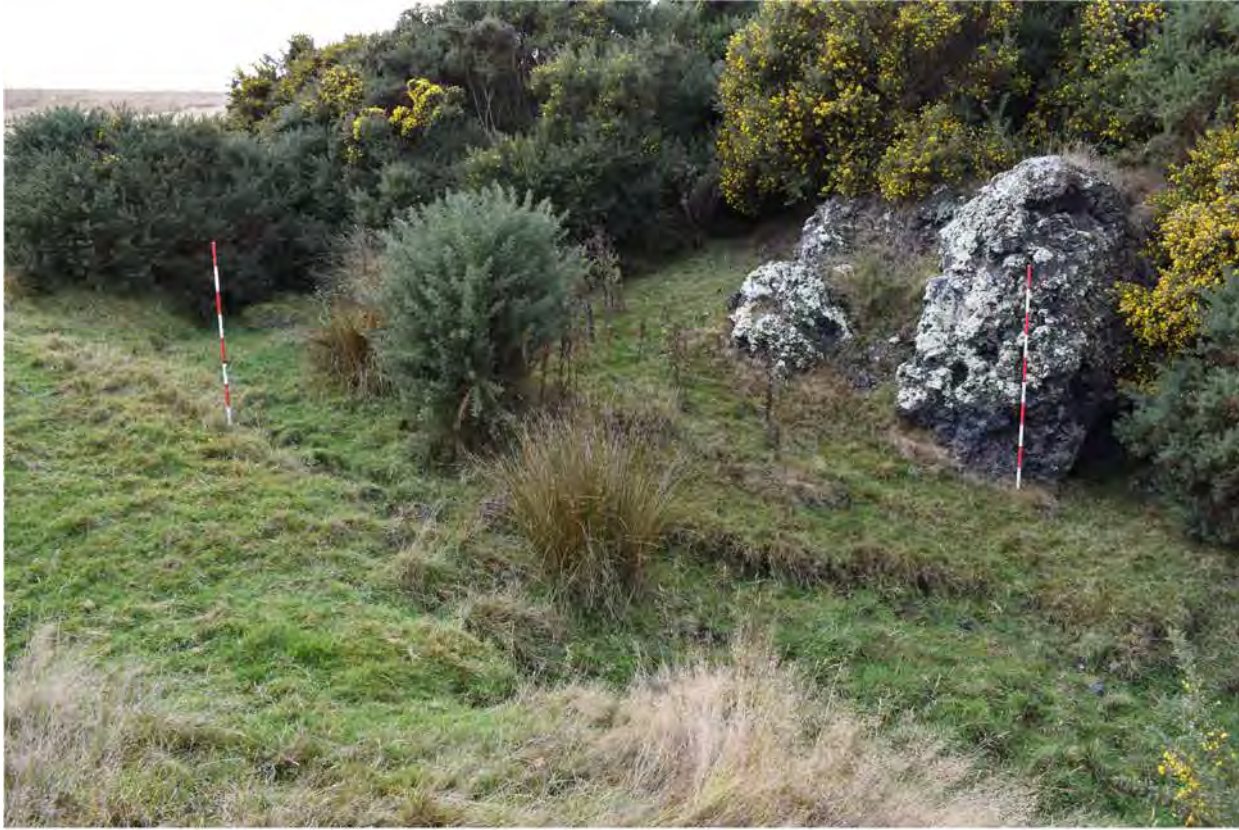
| Condition: | As of the 2022 inspection, the site is now surrounded by dense gorse. Subsurface deposits of porcellanite, or evidence of site use, have likely been subject to disturbance by cattle movement through area. |

F45/3 Porcellanite outcrop with disturbed area (track) in foreground.

Although gorse is encroaching on the outcrop, this site is in a relatively stable condition. An archaeological authority under the HNZPTA will be required to undertake development or other ground disturbance activities within a 20 m buffer of the outcrop.

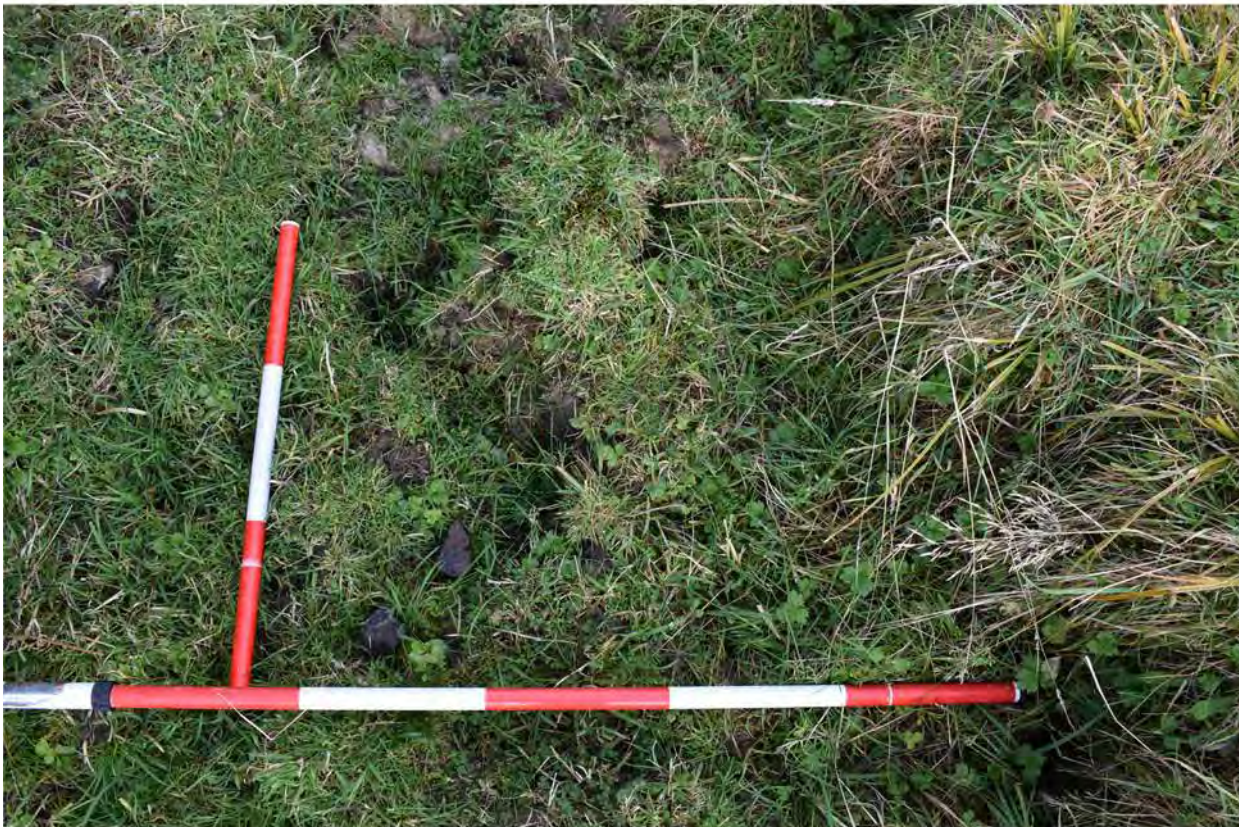
Example of disturbance of track with exposed worked porcellanite.

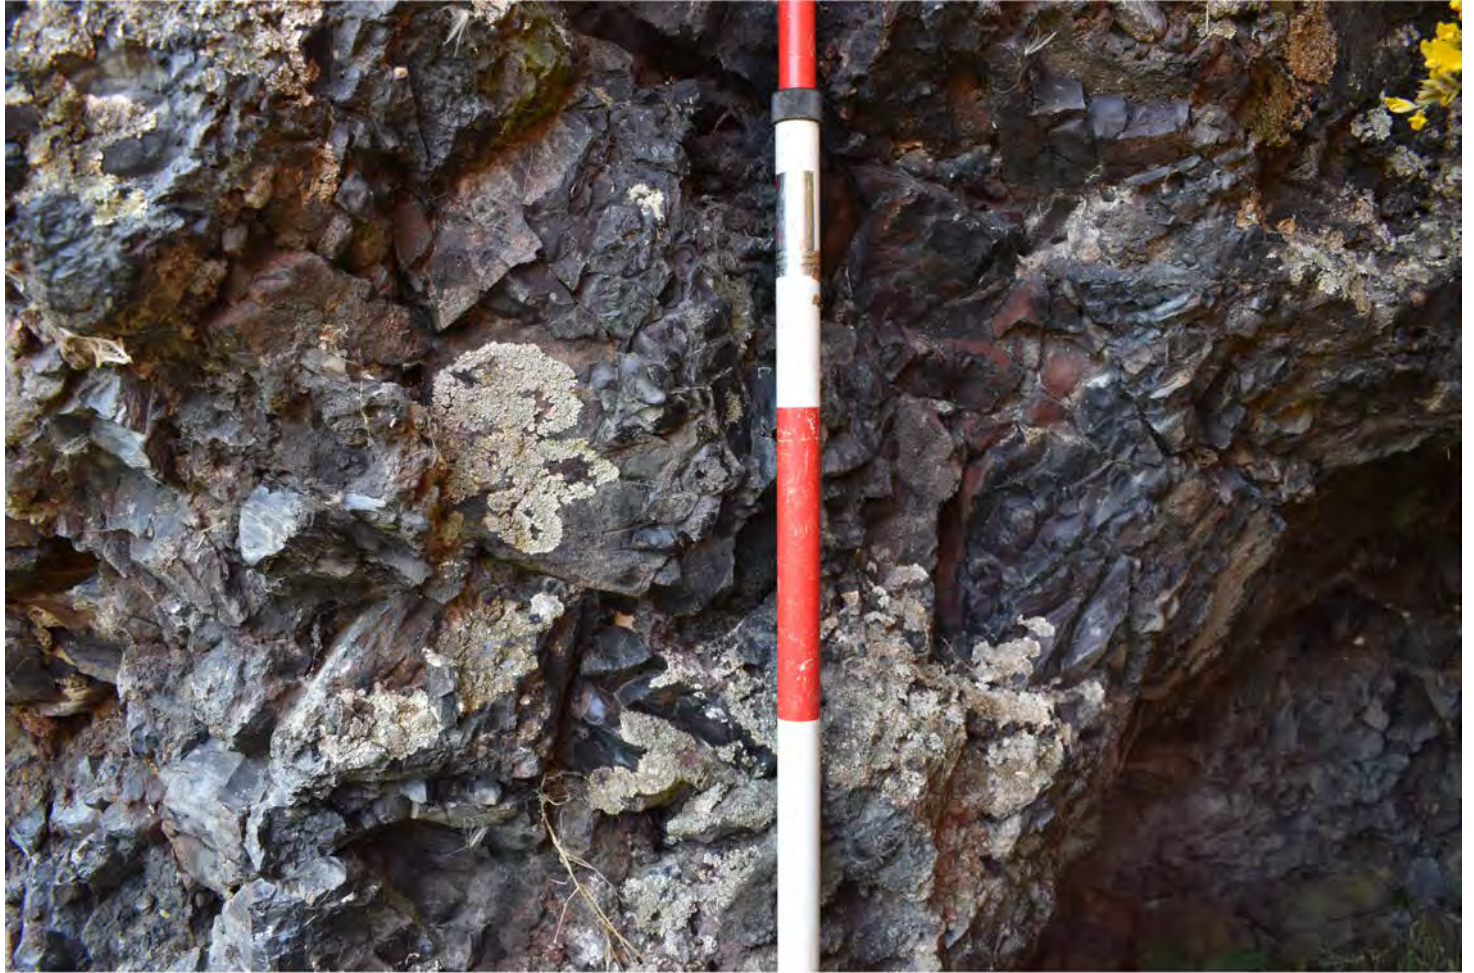
Unweathered area on southern side of outcrop.

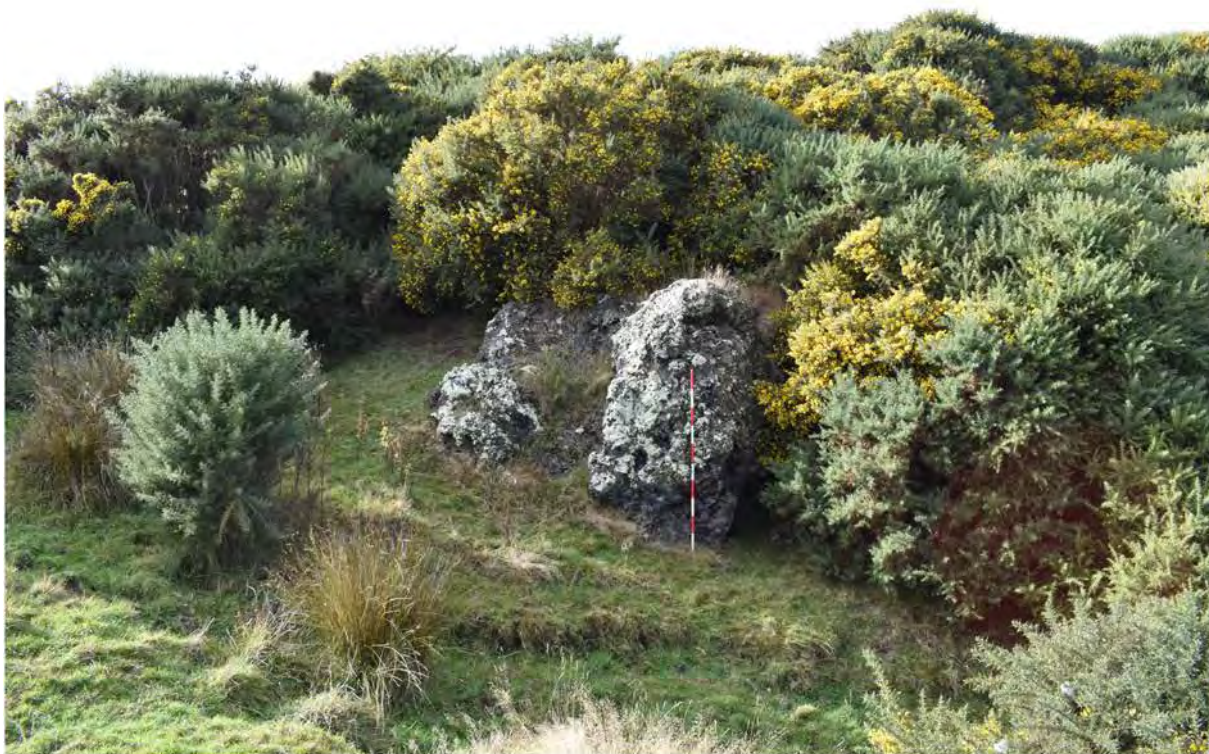
Condition of site April 2022. View to east from NZTM E1294518 N4888688. Track with partially exposed worked material in foreground.

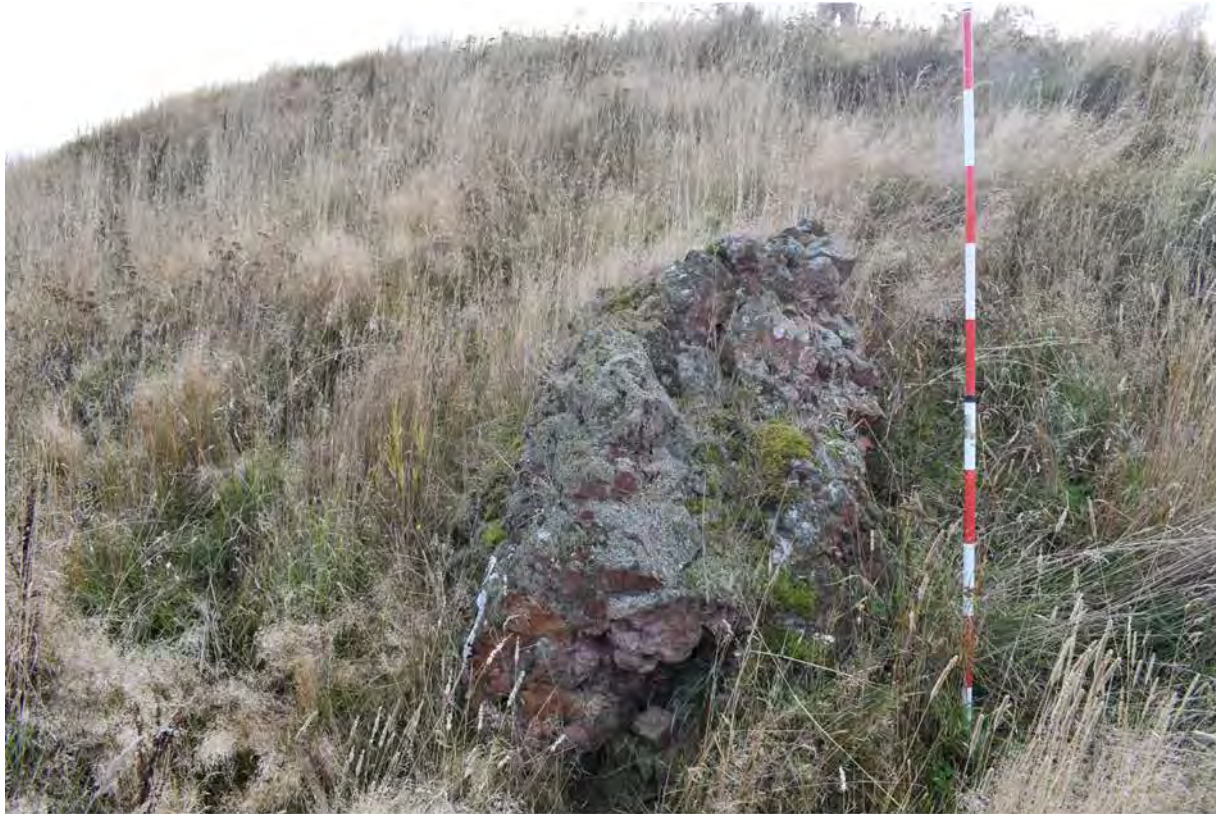
**Condition:** The location where the oven was recorded is fenced off and the paddock has not been disturbed since the last update. The outcrop is also located in this fenced area and is not under threat.

Porcellanite outcrop downslope of F45/6 oven. NZTM E1286797 N4902325

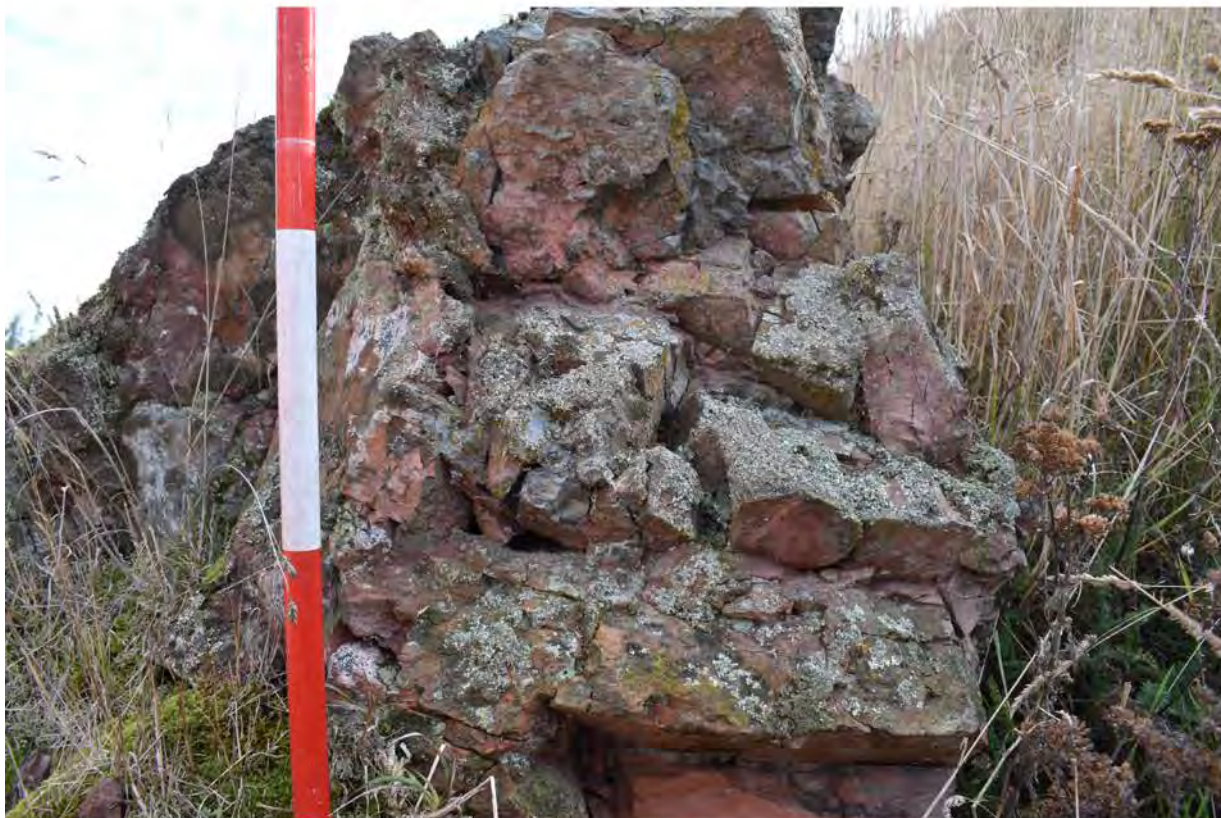
Detail of outcrop surface.

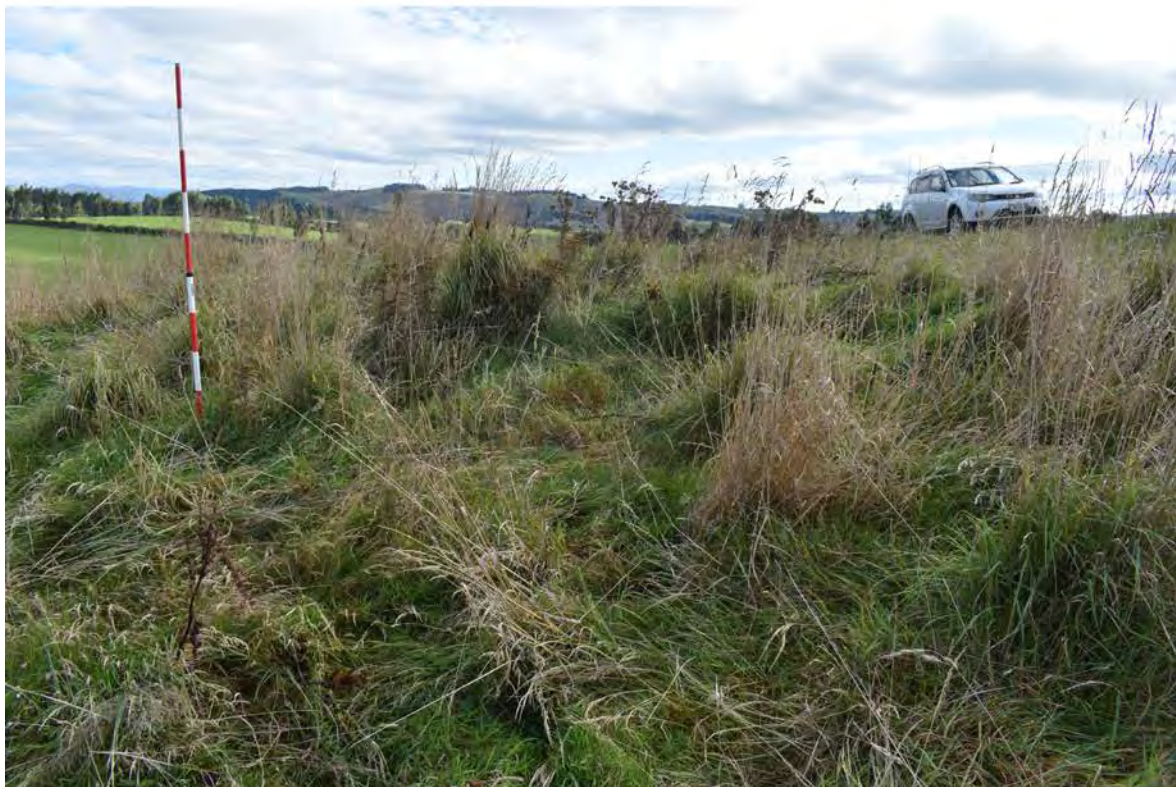
April 2022: Condition of area where oven was originally recorded. View to east, from NZTM E1286792 N490233752.

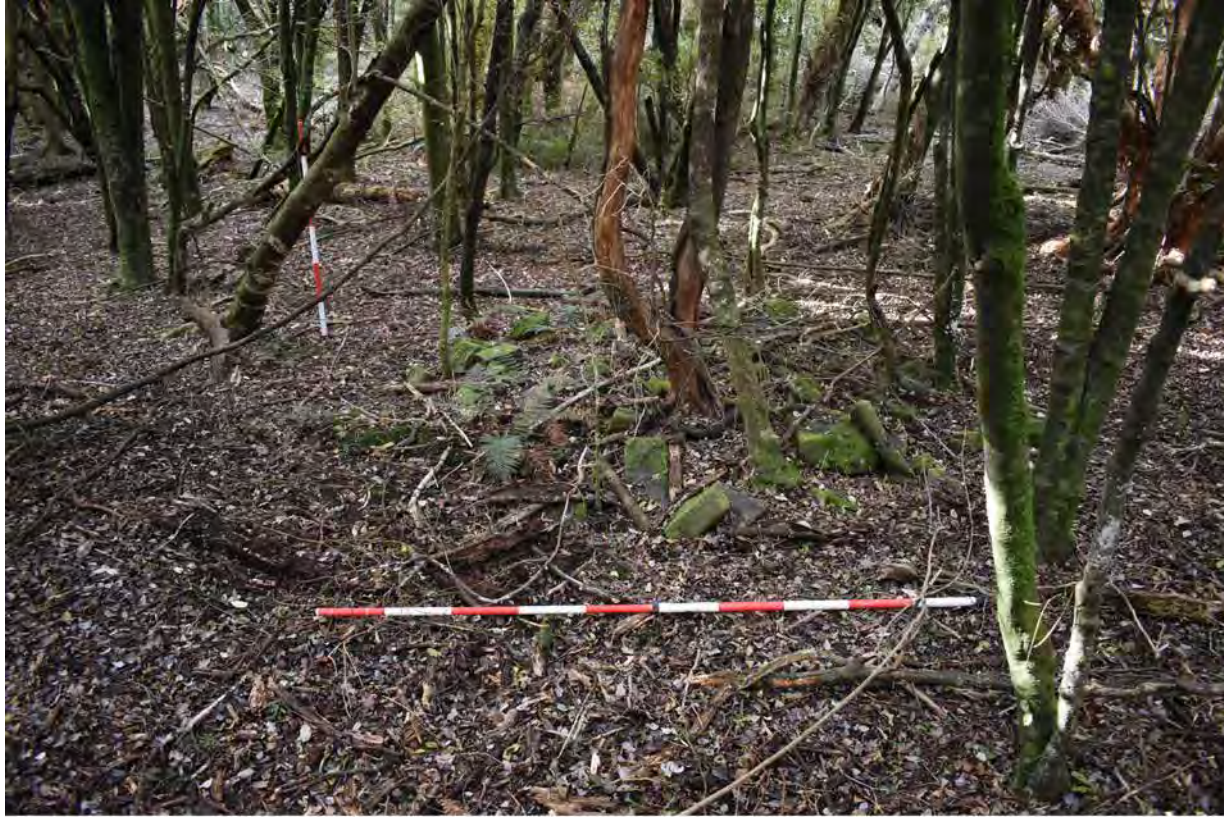
| Condition: | The condition of the hut area appears to be unchanged as of April 2022. Several fragments of glass vessels and ceramics were noted, and the general area is unlikely to be disturbed. |

April 2022: F45/8 Stone pile/collapsed chimney. NZTM E1278893 N4890359.

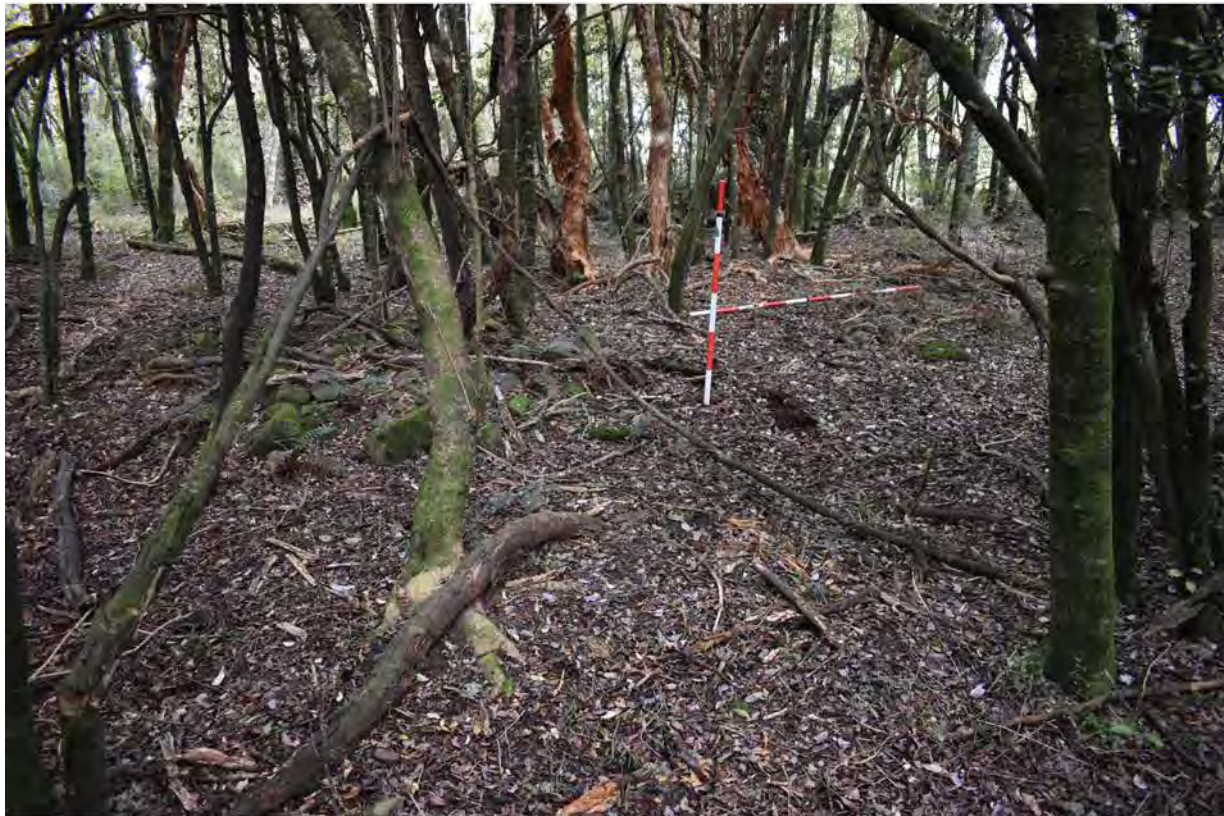
April 2022: Cleared hut floor area (to right of stone pile).

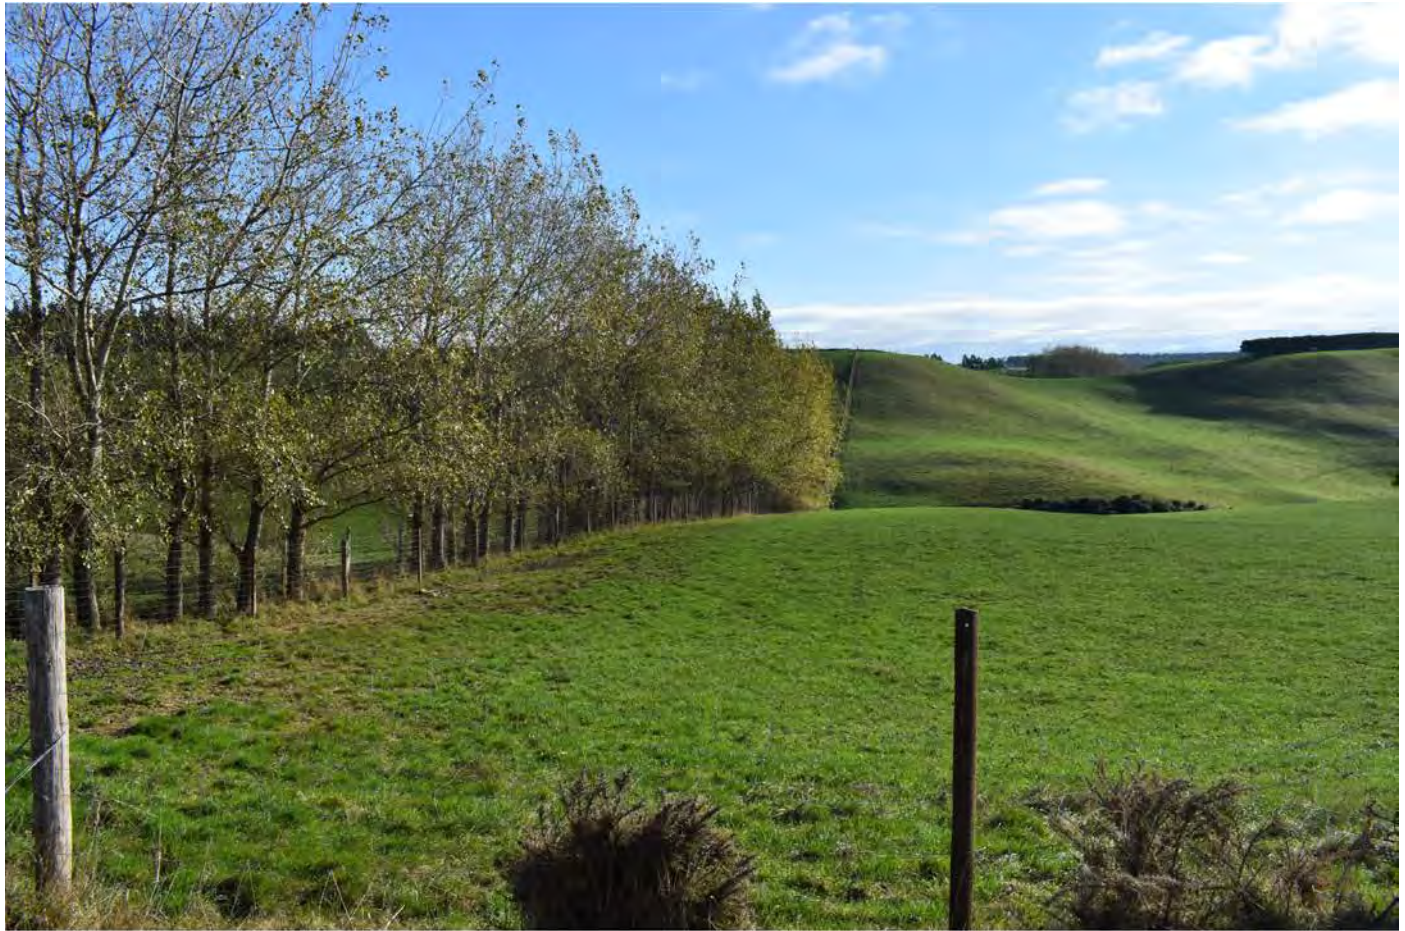
April 2022: View of F46/25 site area from road.

View of F46/25 site area from NZTM E1275046 N4873516, facing west.

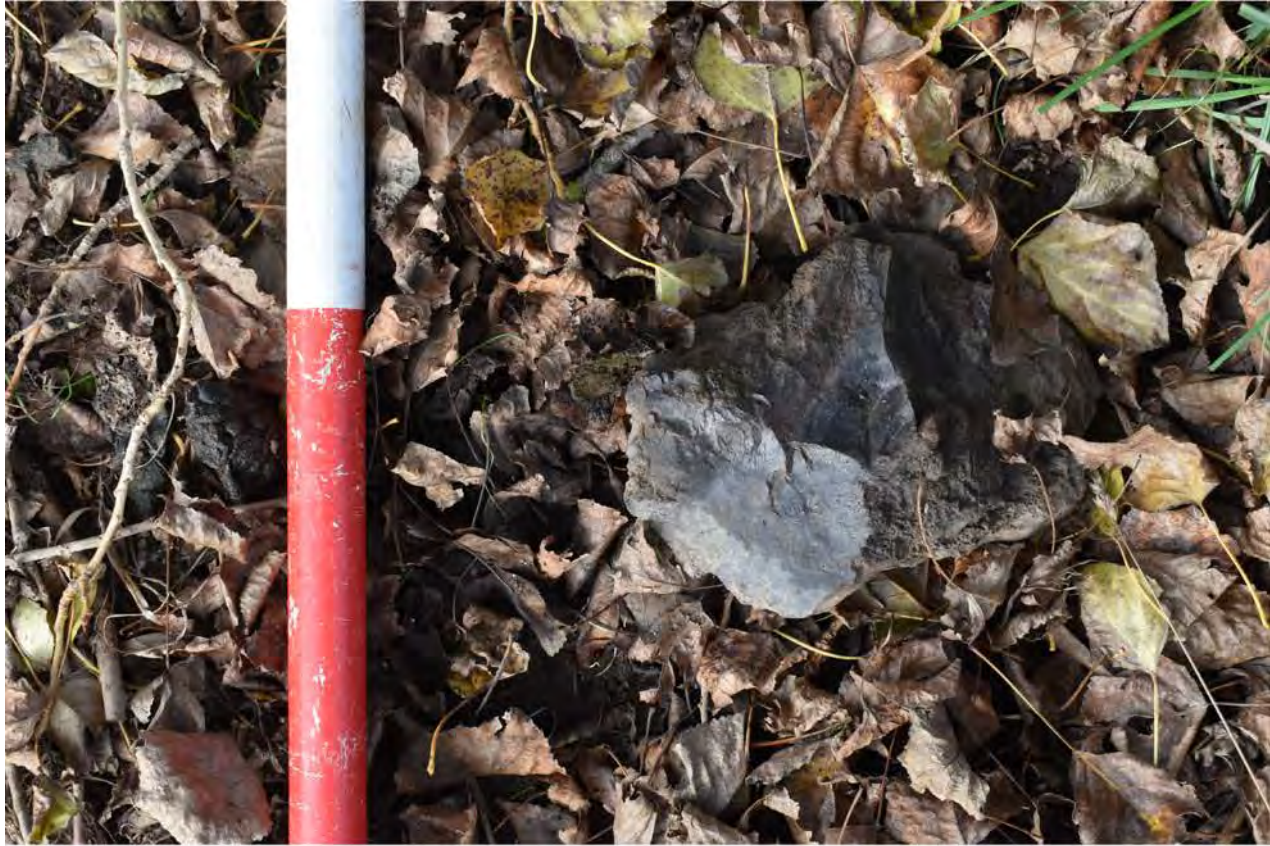
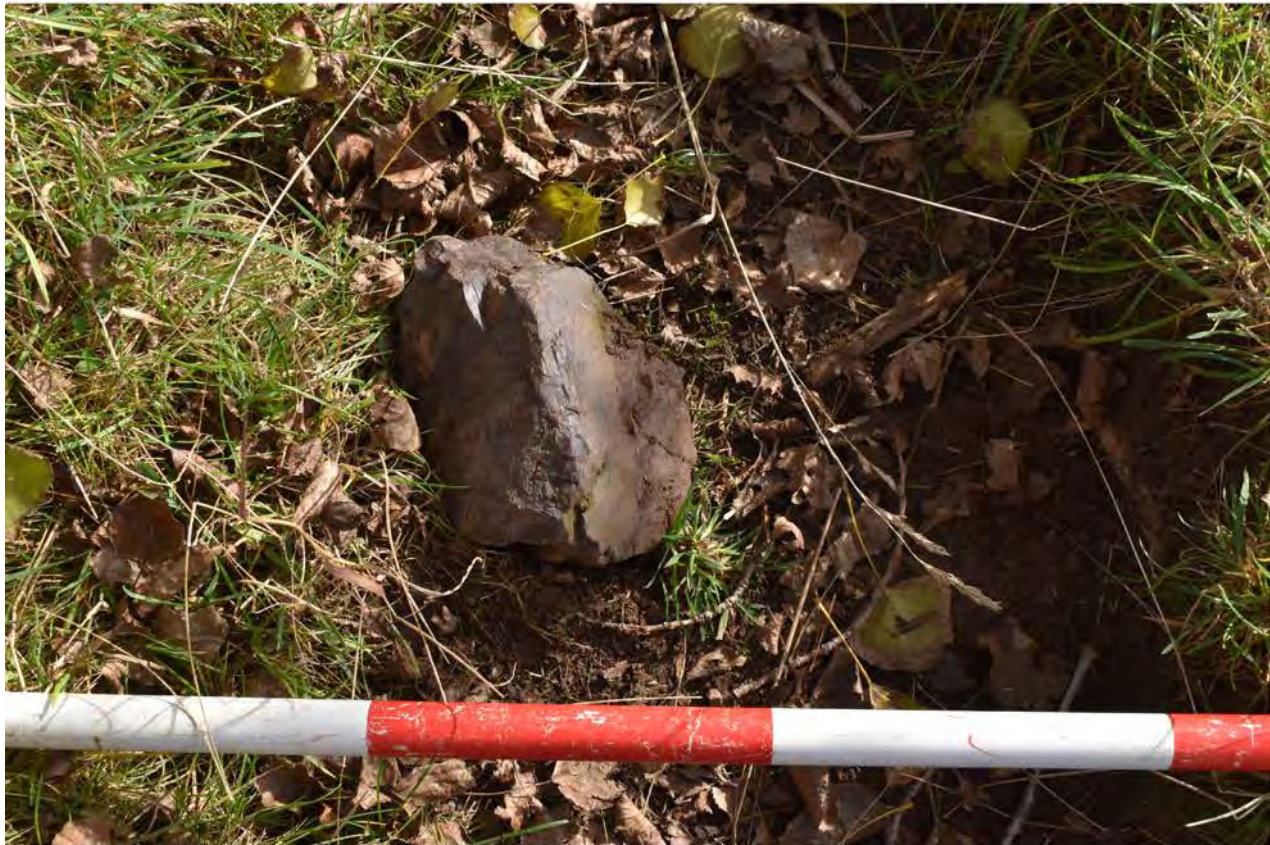
| Summary: | F46/25 consists of sporadic porcellanite cobbles located on the ground surface or partially exposed in the ground over a length of approximately 80 metres along a fence line. A few appeared to have been flaked, although no flakes or large outcrops were observed. |

Examples of porcellanite material observed at F46/25 during February 2022 inspection.

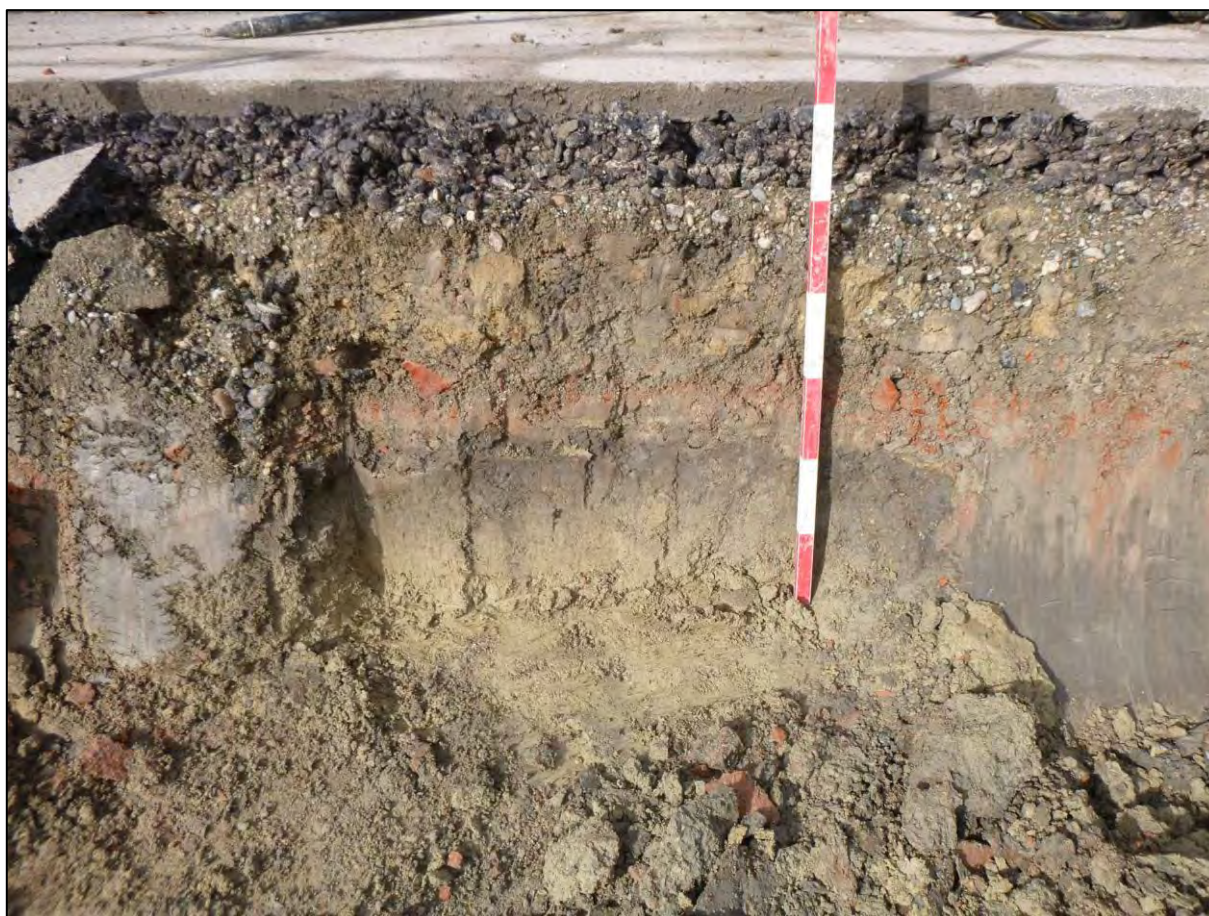
Figure 3. A25, A26, A27, A06, A07, and A11, eastern baulk.

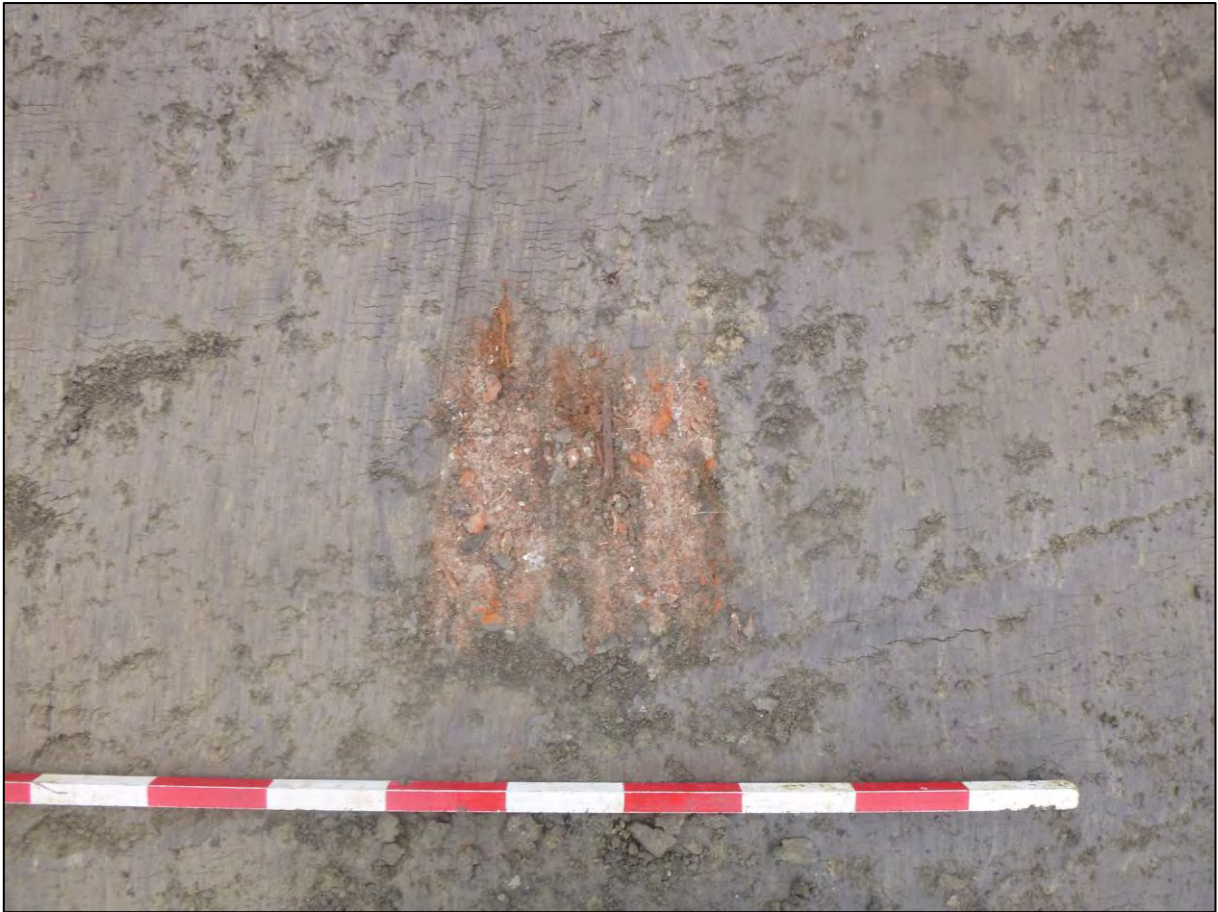
Figure 4. Example of pile cuts seen during site scrape, A13.

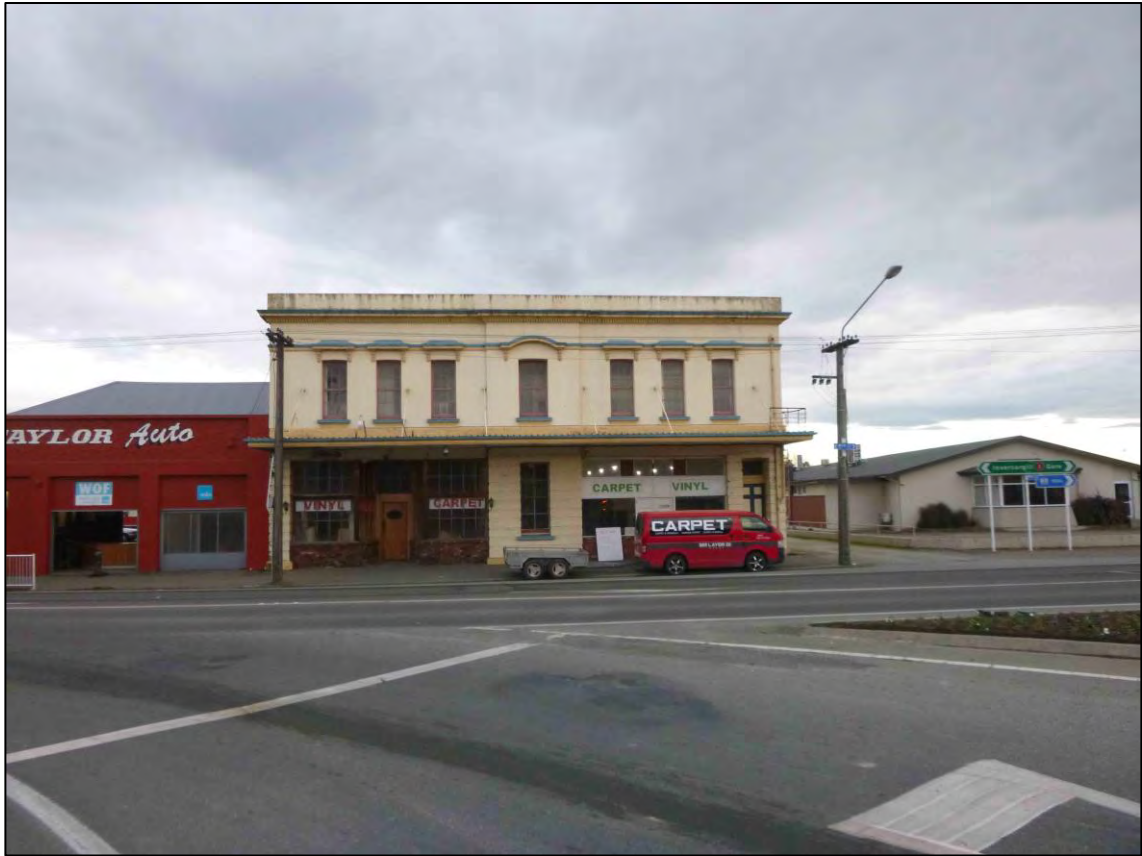
Figure 3. Frontage of extant building (constructed in 1908), to be demolished.
