GEOTECHNICAL DESK STUDY – REABY ROAD

| JOB TITLE | GORE DISTRICT PLAN GEOTECH REVIEW |
| ADDRESS | REABY ROAD, GORE |
| JOB NUMBER | 52665 |

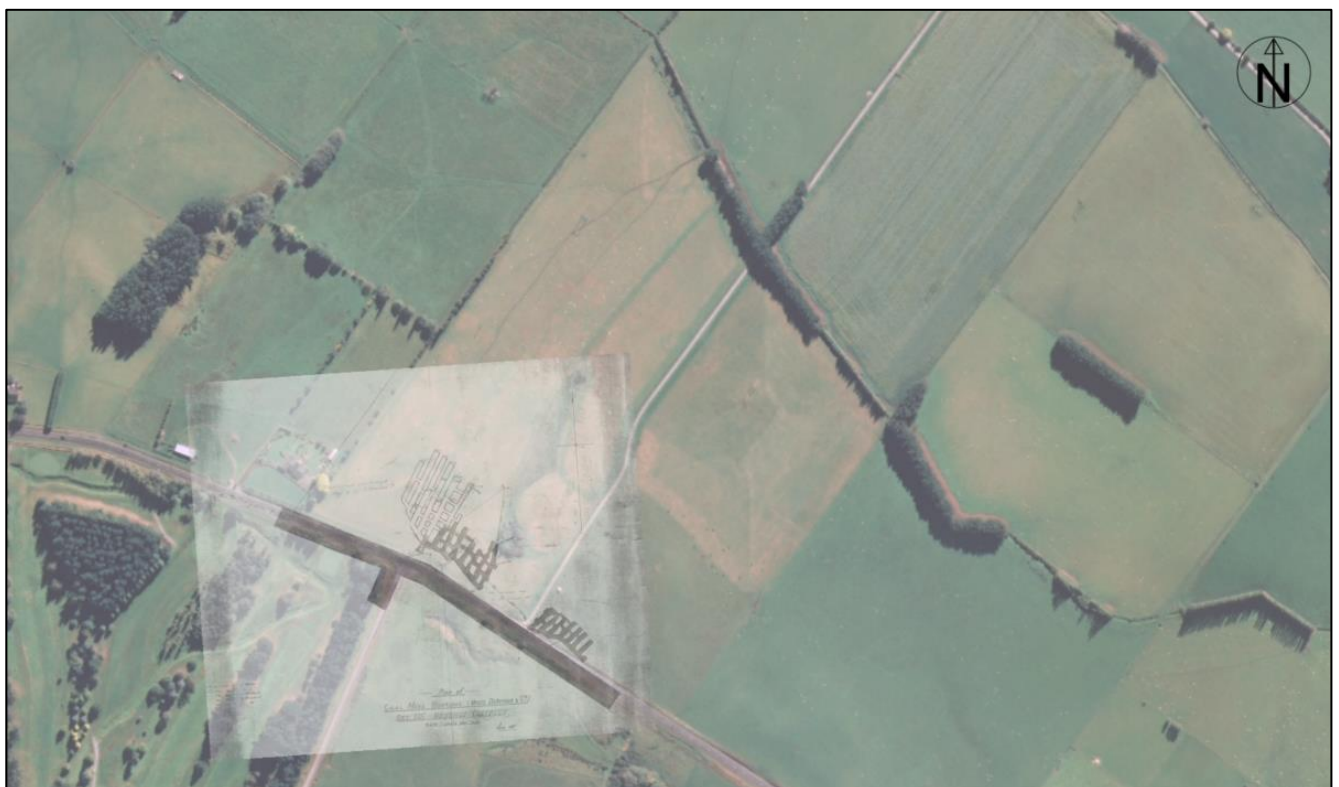
Mining records obtained from the Gore District Council show two main underground mining areas on the southern boundary of the site. The site has been georeferenced in Figure 2, and the general extent of the underground activity has been ascertained (Figure 3).

Figure 2: Georeferencing of old mine workings on the southern perimeter of the study area. The mine workings are primarily underground.

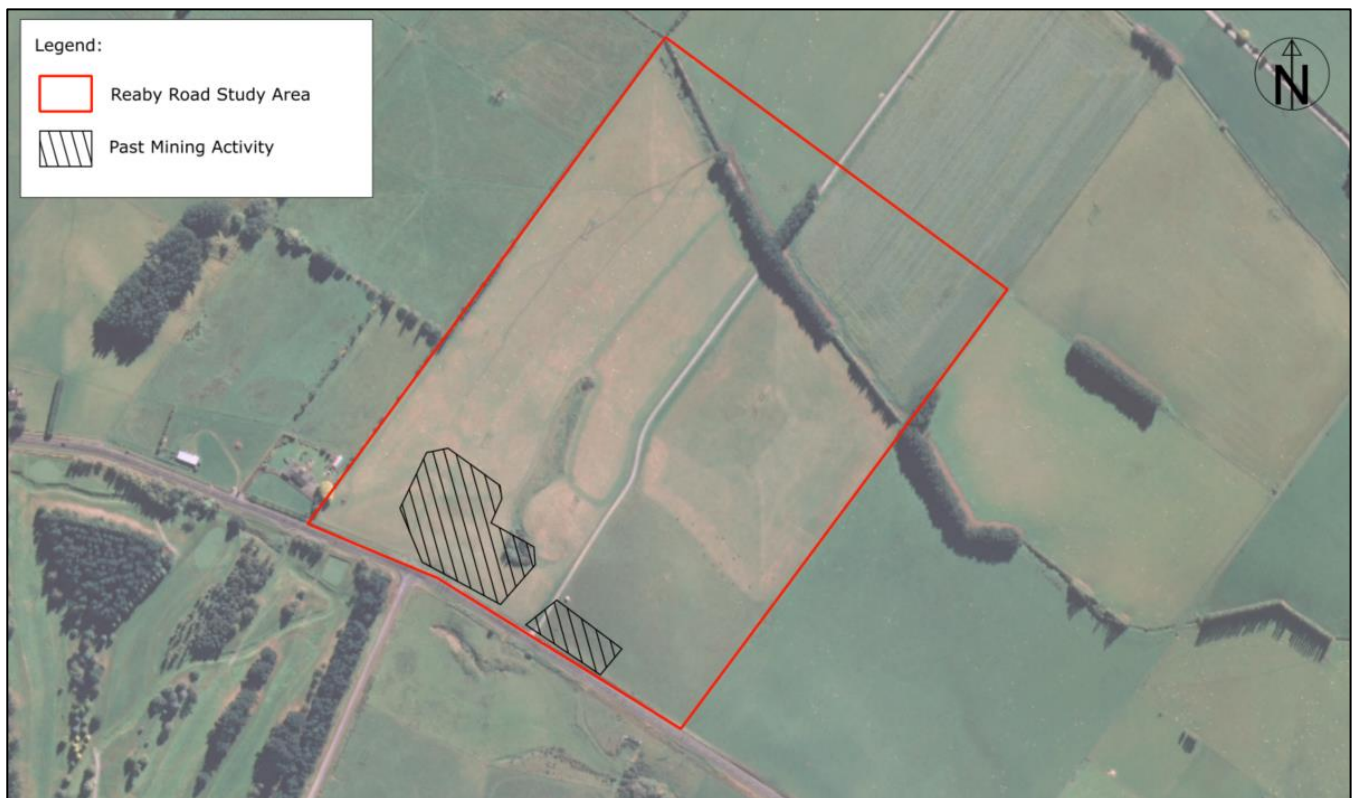
Figure 3: The identified area where underground mining activity has occurred.

Other geotechnical hazards within the study area are generally negligible, with the abandoned mining areas noted in Figure 3 of most concern. Outside these areas development constraints are considered minimal. However, there is a risk that not all mining activities undertaken on the site have been identified.

Underground mining imparts major geotechnical challenges on developments overlying them, this is particularly present on the area adjacent to Reaby Road. The old underground workings were extensive and while information has been provided, it may not be complete, therefore the southern area would require extensive Geotech investigation, which may include excavation, drilling and geophysics.
