# Gore District: Archaeological Appraisal

Gore District Council

May 2022

**Report No.** 306

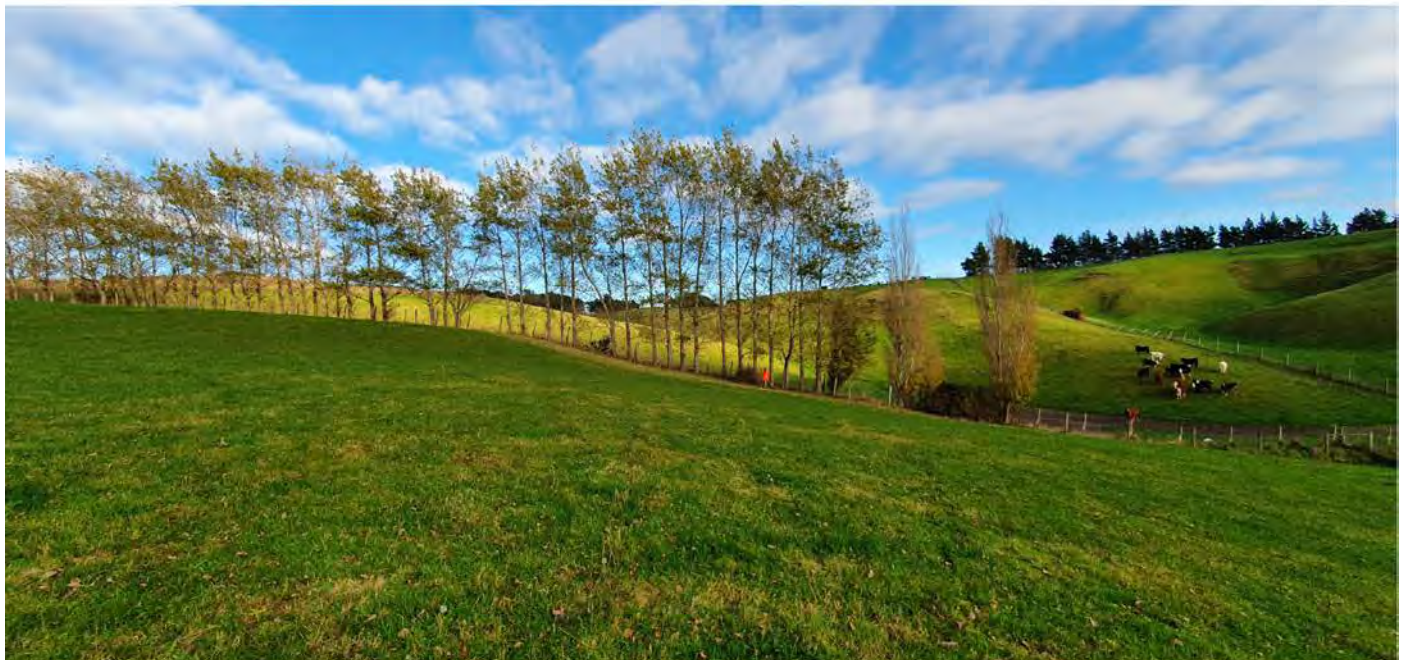
View of F46/25 site area from NZTM E1275046 N4873516, facing west.

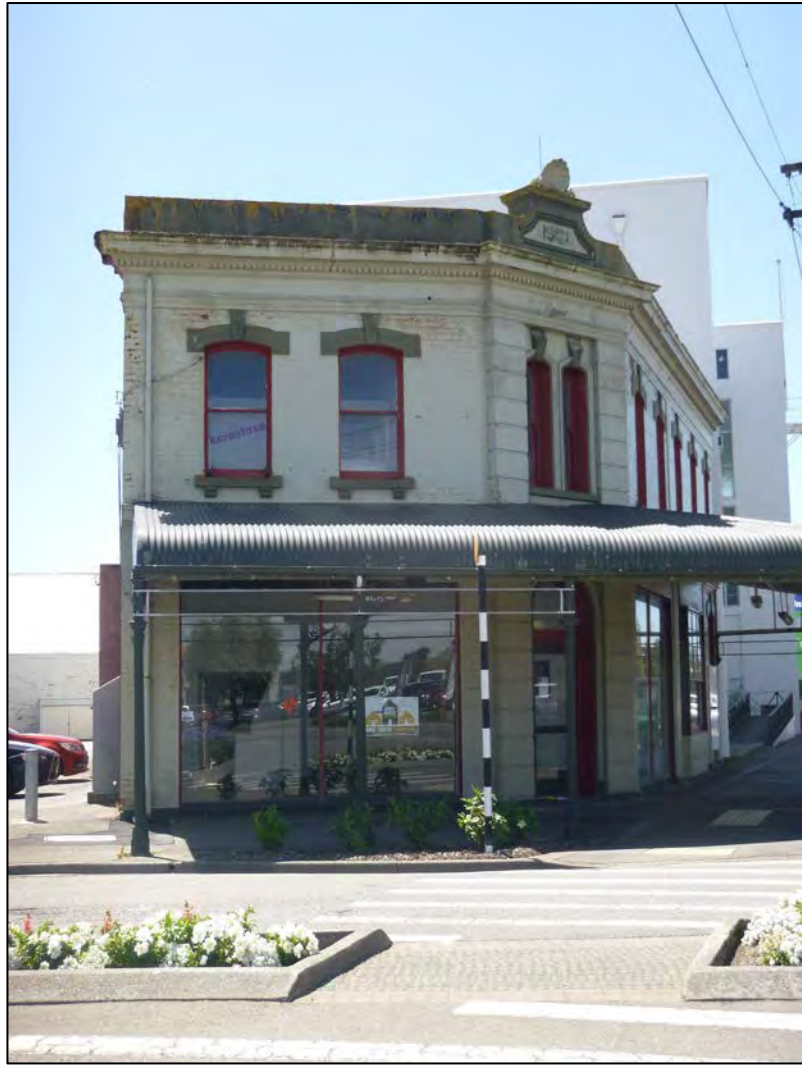
Figure 5. South elevation of 128 Main Street, Gore (Ross 22/1/2019).

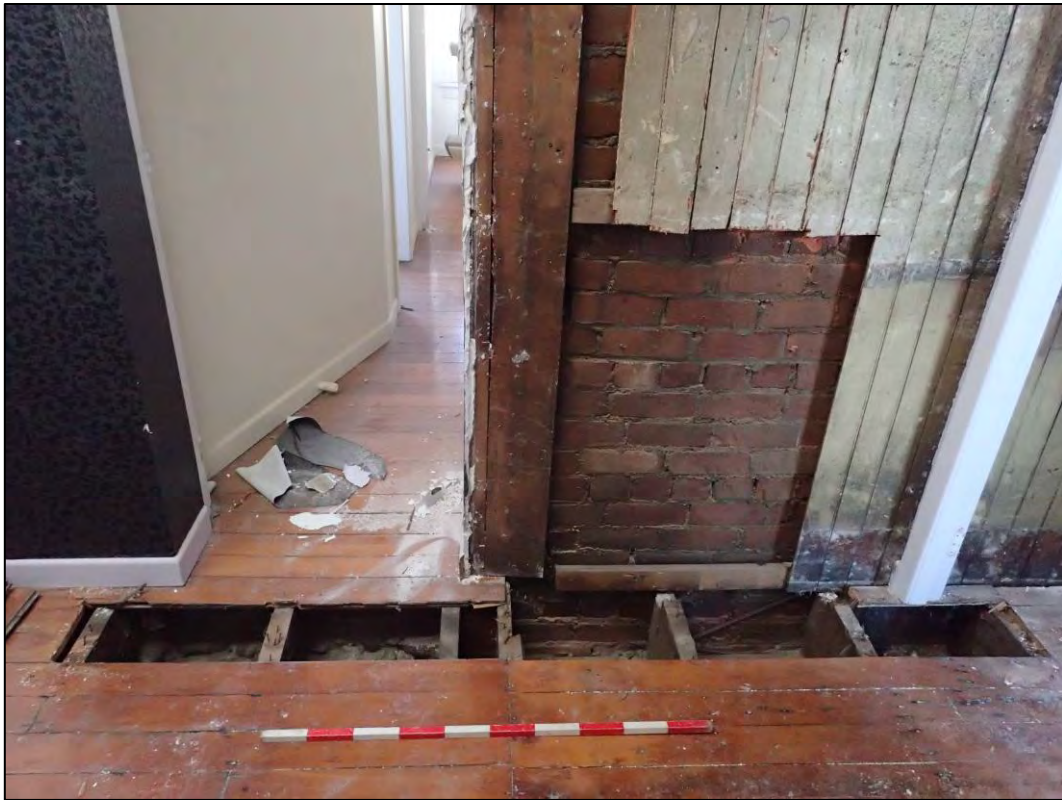
Figure 3. Sample Area showing different joists between original building extant and closed in rear stair area.

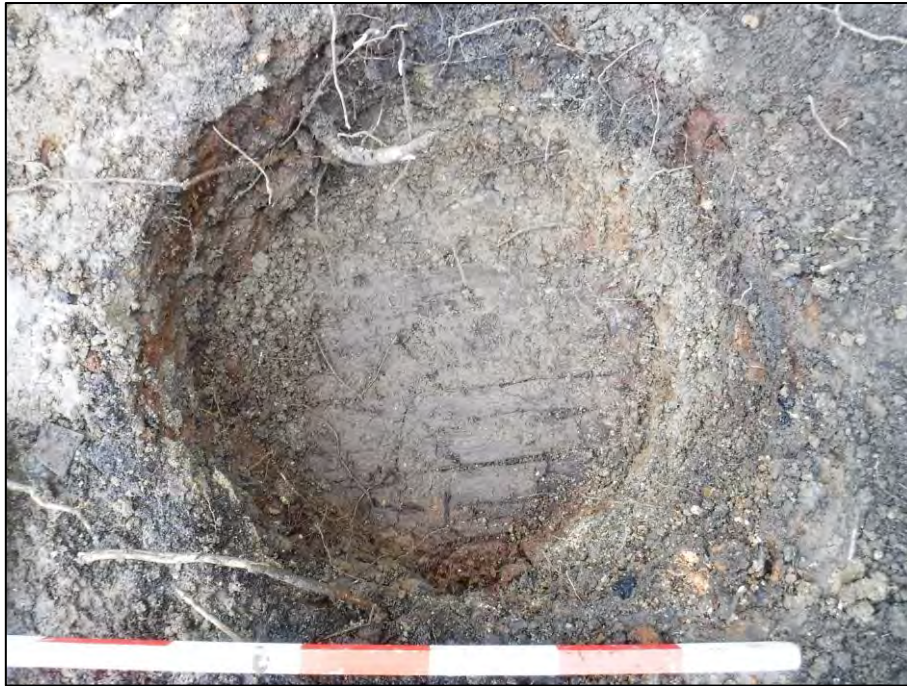
Figure 5. Barrel latrine (A009) after being excavated, facing east (Julia Lewis, 2018).
