**GEOTECHNICAL DESK STUDY – SOUTH MATUARA**

| JOB TITLE | GORE DISTRICT PLAN GEOTECH REVIEW |
| ADDRESS | <b>SOUTH MATAURA</b> |
| JOB NUMBER | 52665 |

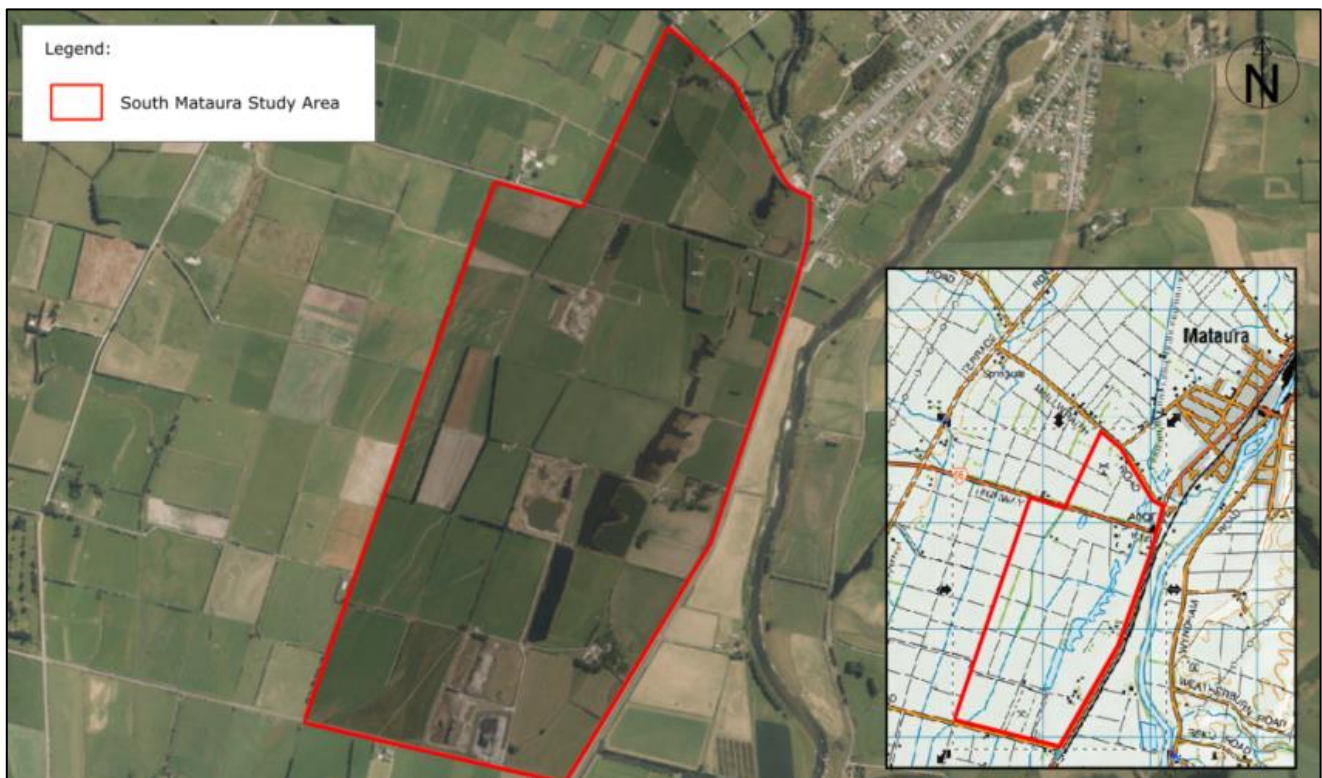
Figure 1: An aerial photograph of the South Mataura study area. Ponds seen in area are often the result of past coal mining activity.

This report concentrates on South Mataura study area (Figure 1).

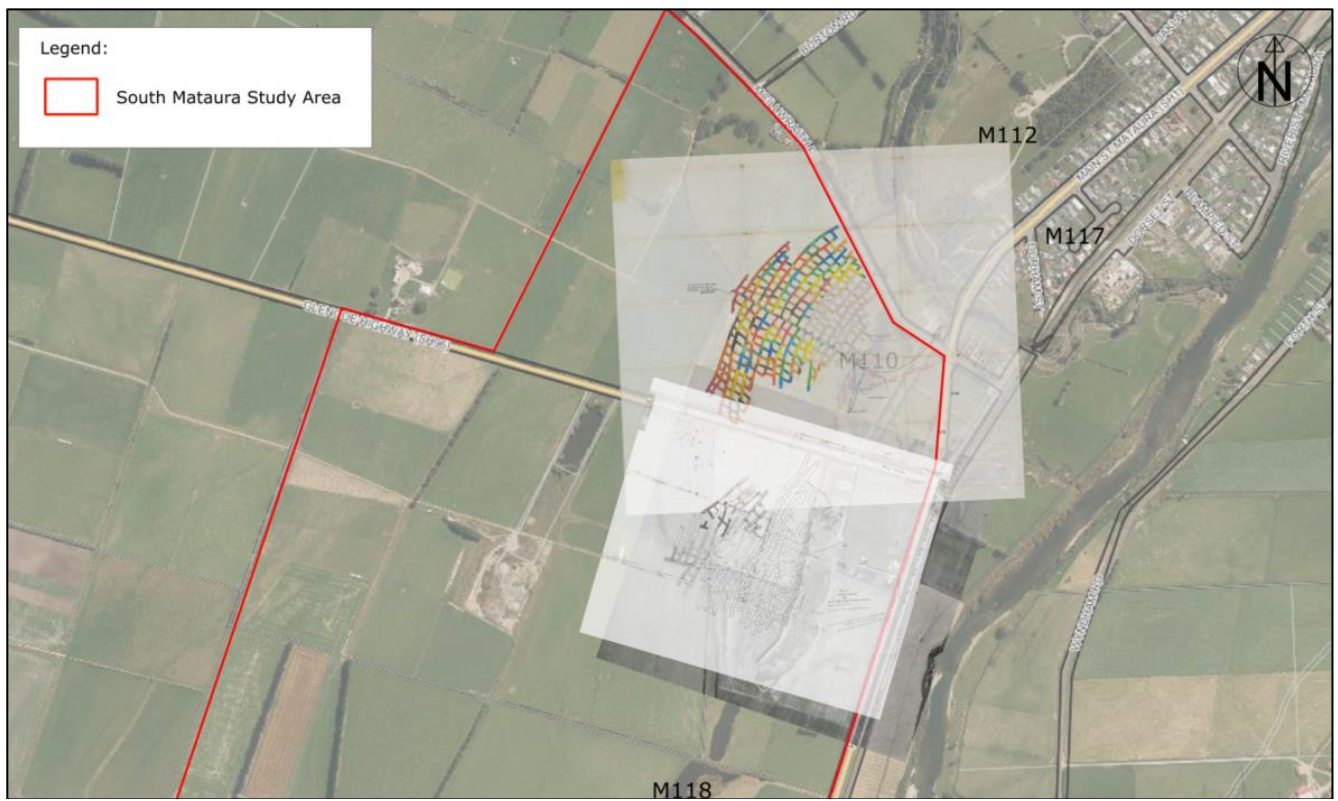
Figure 2: Georeferencing of the underground mine workings for the northern extent of the Study area, no other underground mining was found during this review.

Mining records obtained from the Gore District Council (Appendix A), show at least two underground mines and a series of open cast mines, running north-south the length of the proposed area adjacent SH1. The mines are designated M100, M113 and M118. Georeferencing of the past mining activity, from the mining records and aerial photographs (Figure 2) has allowed the general extent of the open cast and underground mining activity to be ascertained, and is outlined in Figure 3. Two underground mines are indicated on the plans west of the opencast pits, north and south of the Glencoe Highway. It appears no other underground mining has been undertaken, however, at the southernmost extent, an excavation that appears similar to a mining portal has been constructed which may indicate either the presence or plan to conduct underground mining. However, no further information in the area was found to indicate underground mining was undertaken.

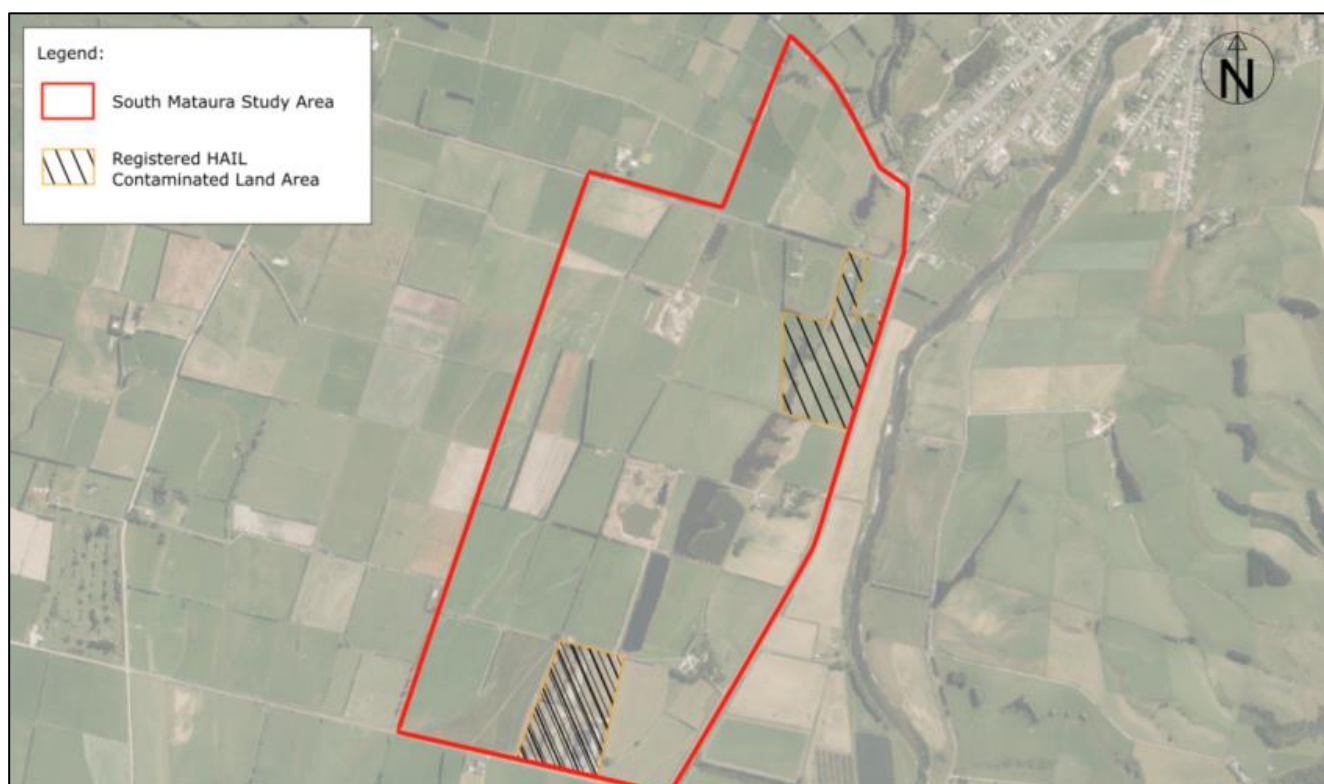
Figure 6: HAIL contaminated land identified from Environment Southland's Beacon website.

An area has been identified on the HAIL register by Environment Southland (SLUS number 20191040). The HAIL category lists the site as "A8. Livestock dip or spray race operations; E7. Mining industries", and is shown in .
