**GORE DISTRICT COUNCIL**  
**HISTORIC HERITAGE ITEM RECORD FORM**

**HERITAGE ITEM NAME** former Bank of New Zealand & bank manager's residence

**ADDRESS** 90-92 Kana Street, Maitāura

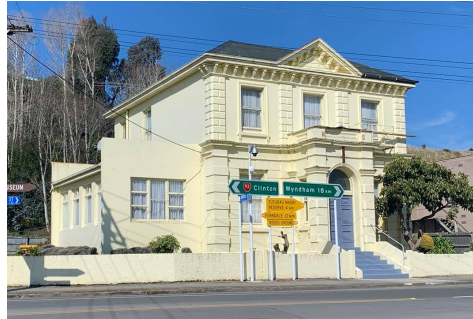
**PHOTOGRAPH**

(October 2021)

Two-storey building with irregular rectangular footprint and centre-gutter hipped roof; single-storey extensions to the north, south & east. Symmetrical façade, with portico entrance and central pediment above bracketed eaves. Pilasters with quoin or block detailing; panelled entrance door approached via a short flight of steps. Double-hung sash windows with casement type windows in later additions.

Brick, cement plaster, corrugated metal.

Additions to north and south elevations (mid-20<sup>th</sup> C).

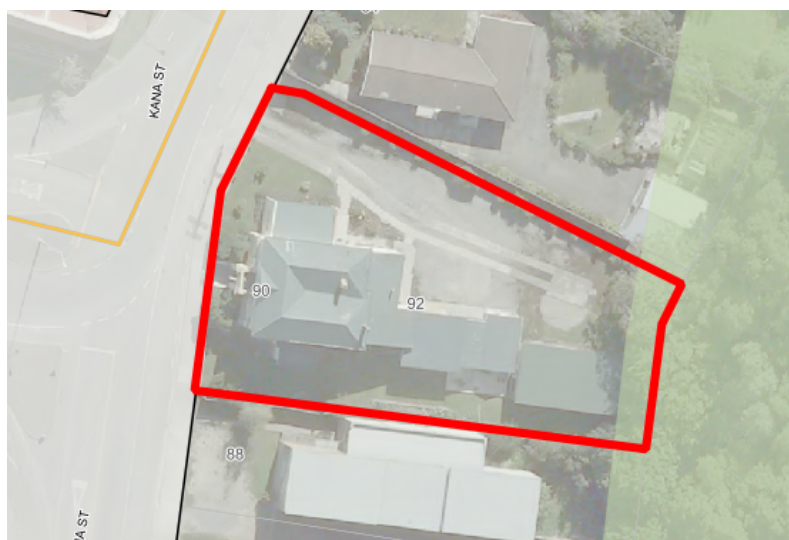
The former Bank of New Zealand stands on the east side of Kana Street, overlooking its intersection with Bridge Street. The building forms the eastern terminal vista along the length of Bridge Street and stands near the former Macgibbon store at 61 Kana Street. The scheduled setting is the land parcel on which the building is located.

Extent of scheduling, former Bank of New Zealand, 90-92 Kana Street, Mātaura.
