# Gore District: Archaeological Appraisal

Gore District Council

May 2022

**Report No.** 306

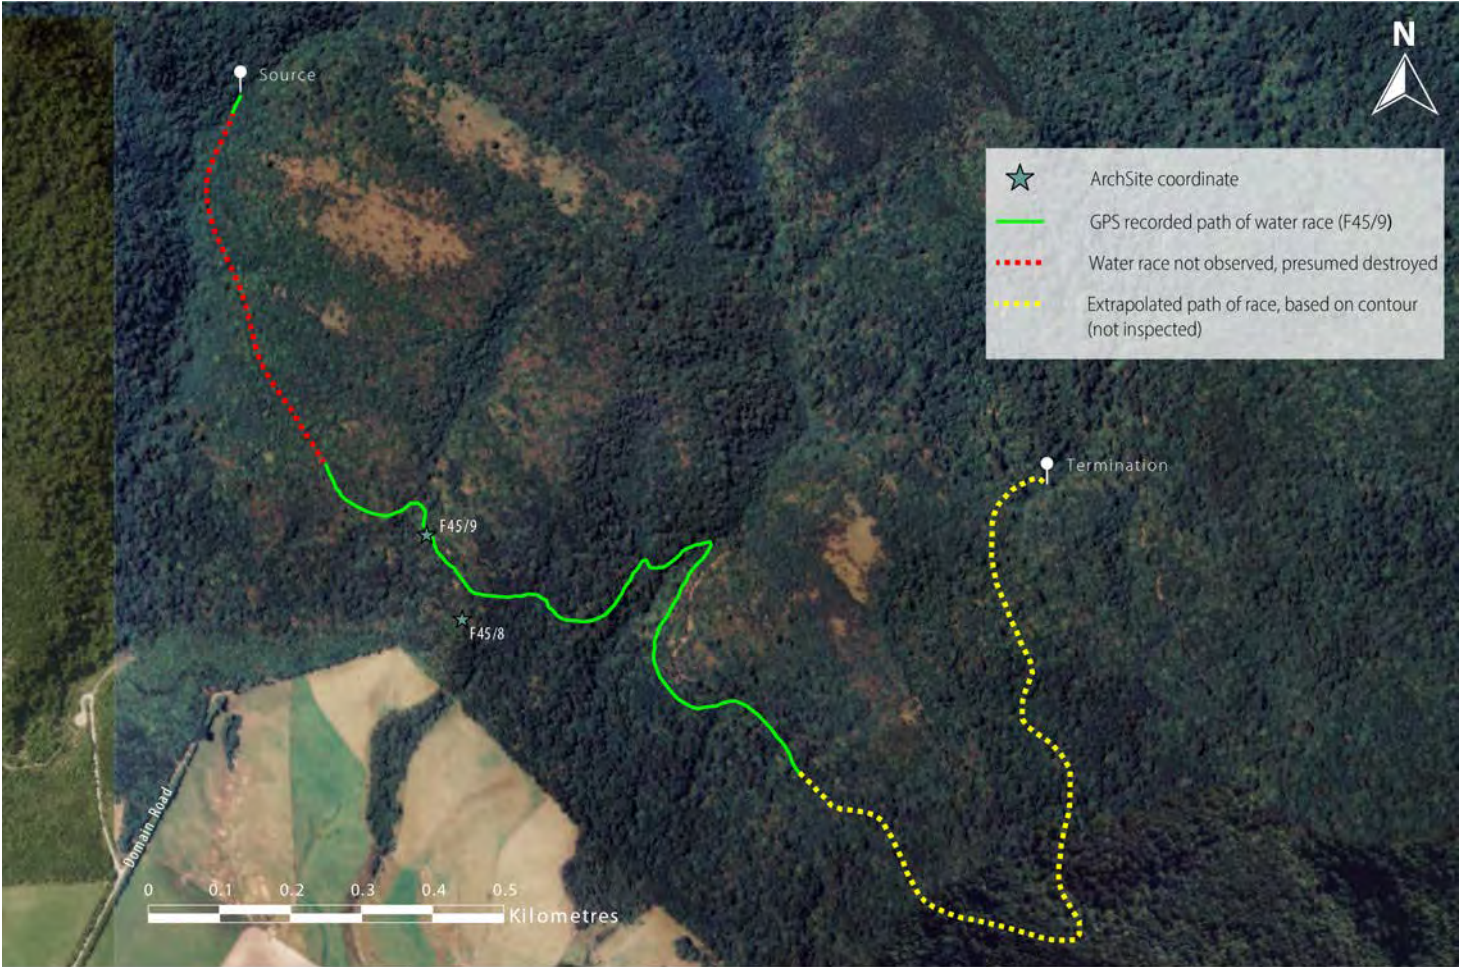
Path of water race F45/9 and location of nearby hut floor site (F45/8).

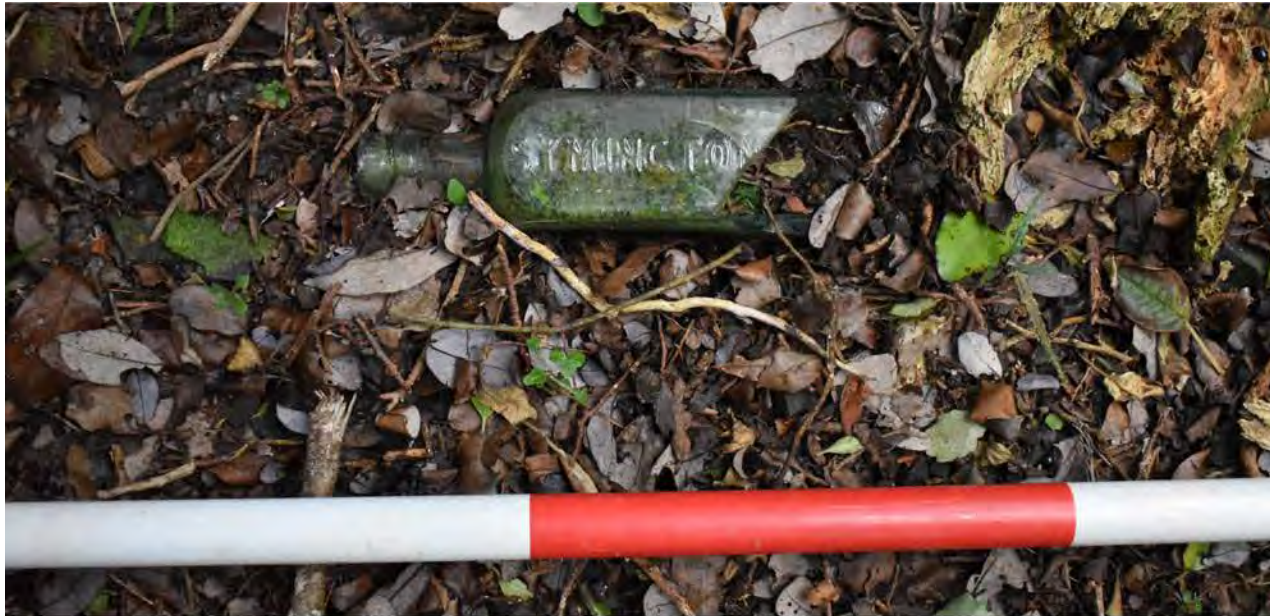
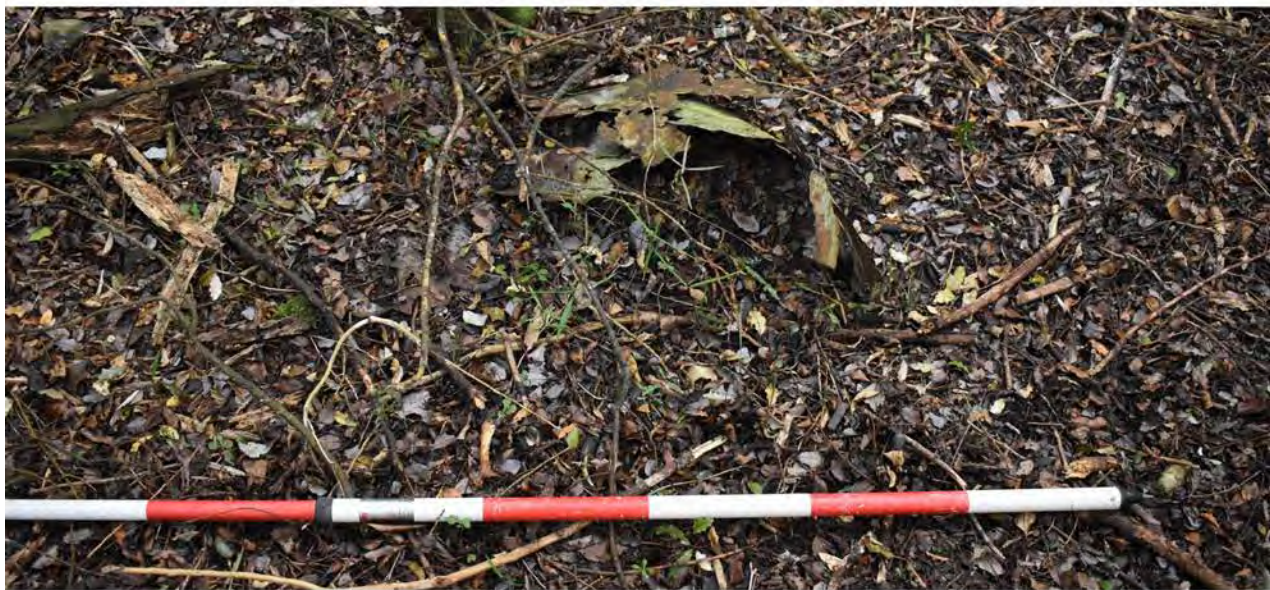
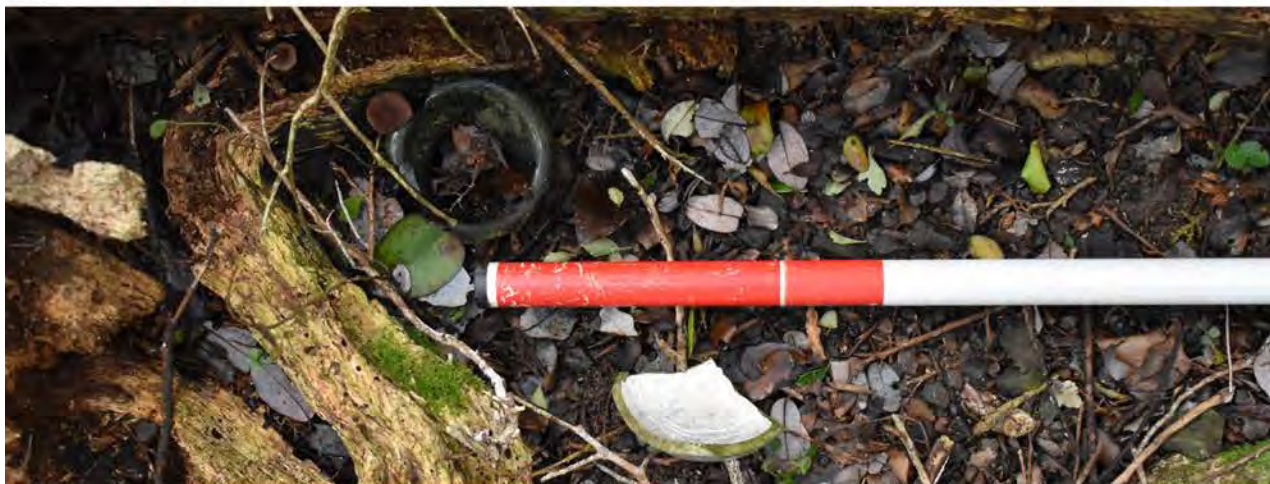
| Condition: | The condition of the hut area appears to be unchanged as of April 2022. Several fragments of glass vessels and ceramics were noted, and the general area is unlikely to be disturbed. |

April 2022: Examples of glass, metal and ceramics present at F45/8

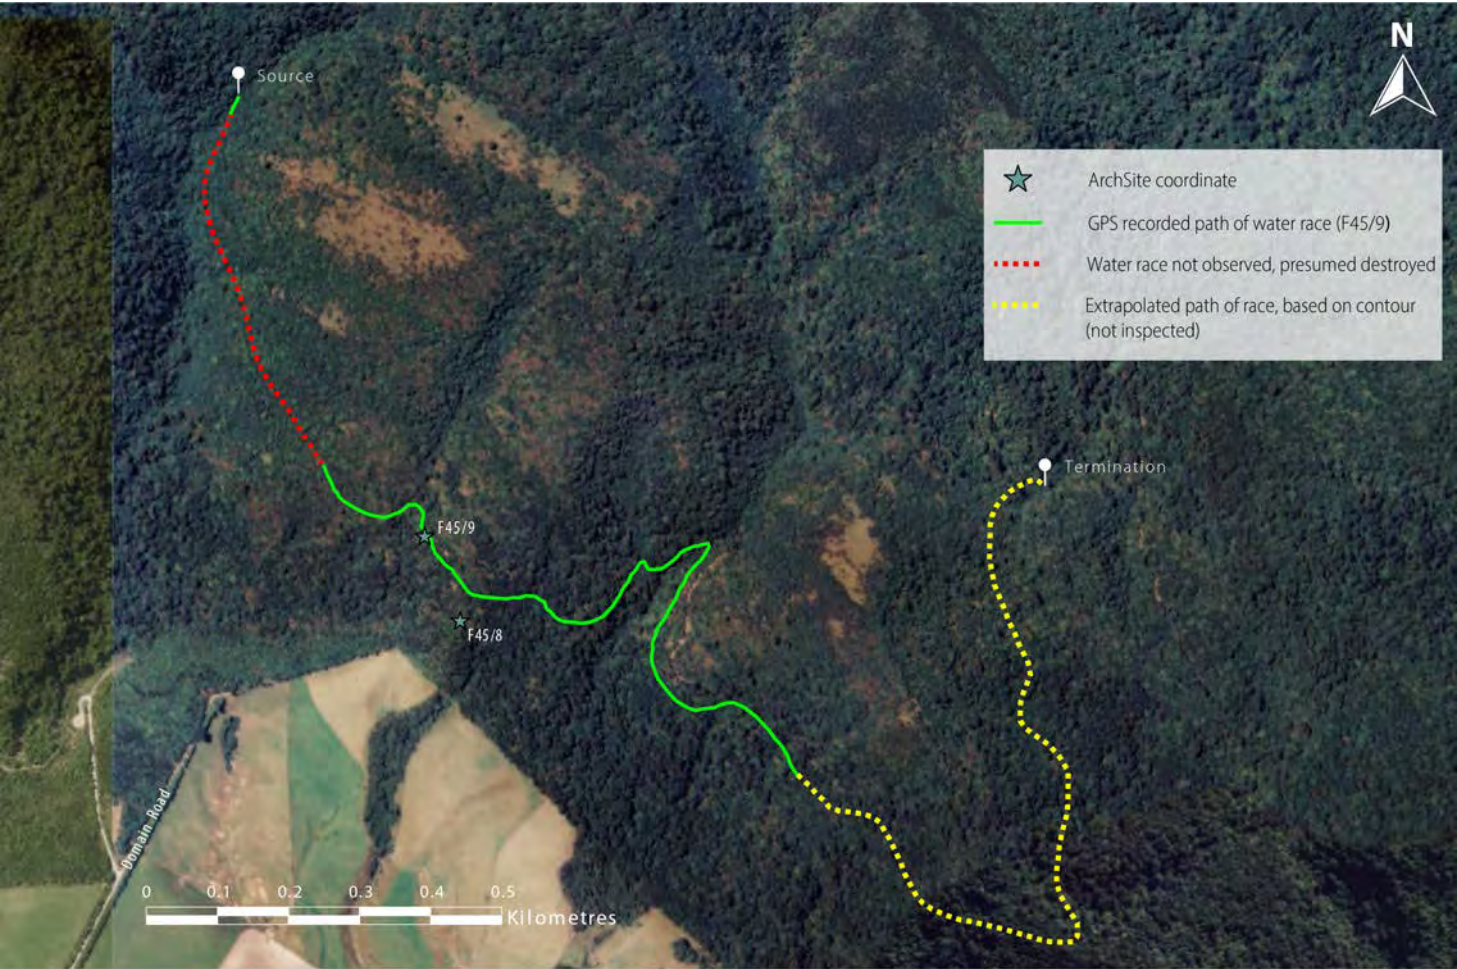
| Condition: | The race is in variable condition throughout its length, and a large stretch of the race (approximately 550 m) appears to have been destroyed by formation of the track through the forest. |

Path of water race F45/9 and location of nearby hut floor site (F45/8).

The race is in variable condition throughout its length and a large section has been destroyed by track formation. Any future track construction or major maintenance projects that may damage additional sections of the track should be undertaken under an archaeological authority obtained under the HNZPTA.

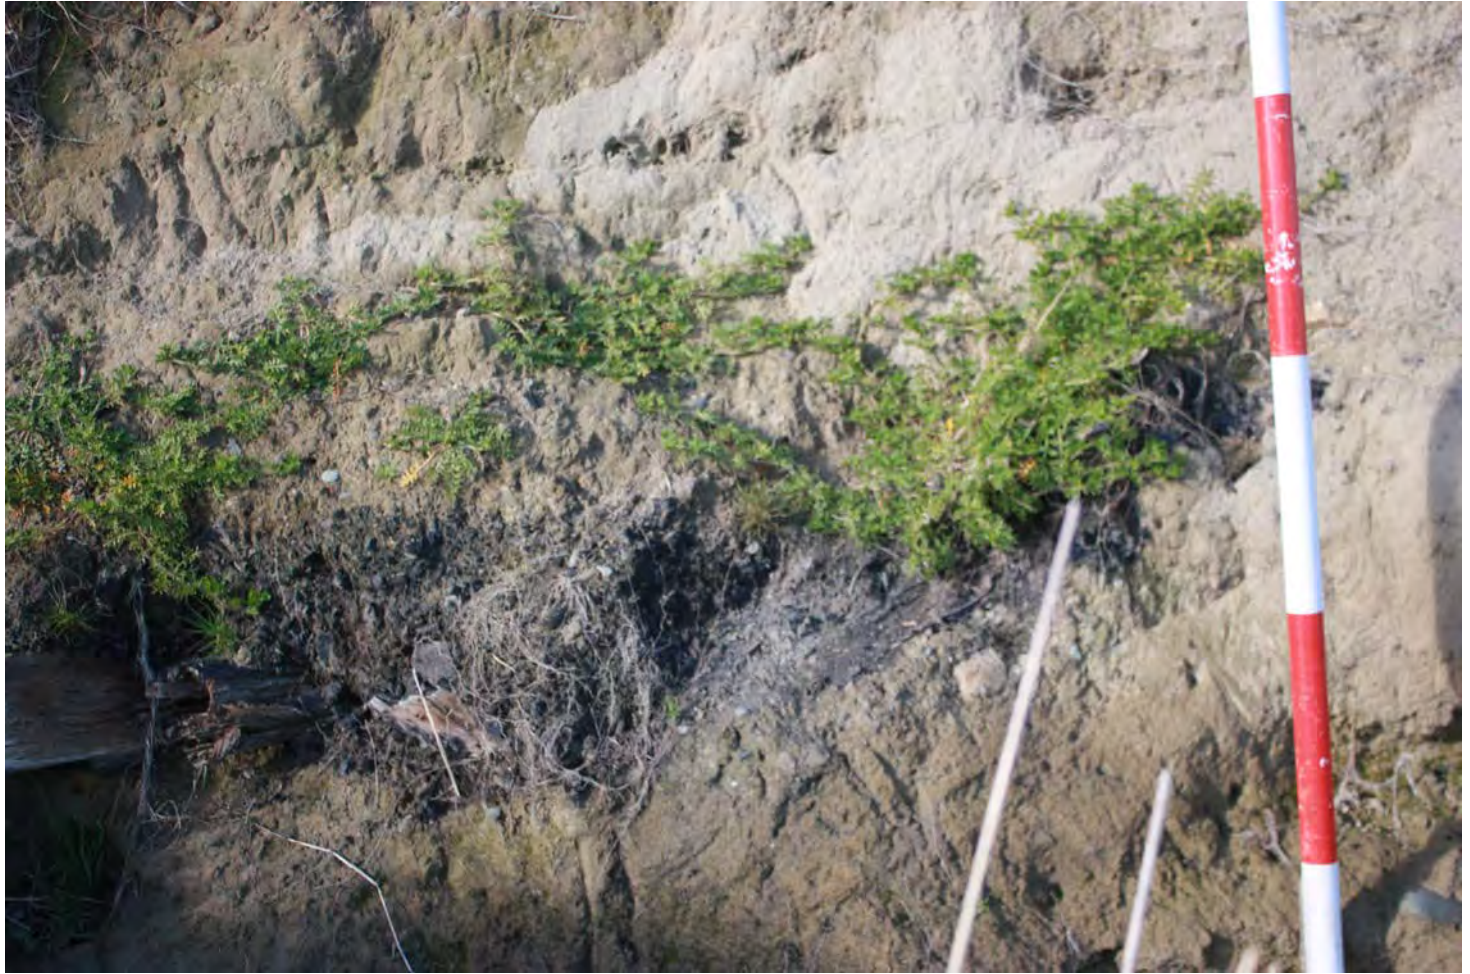
| Condition: | The exposed sections of the slumped riverbank indicate that the site is actively eroding, although it is unclear how much of the site has been lost since its initial recording. |

Exposed feature on east bank of the Maitara river, Nikole Wills 25 June 2020

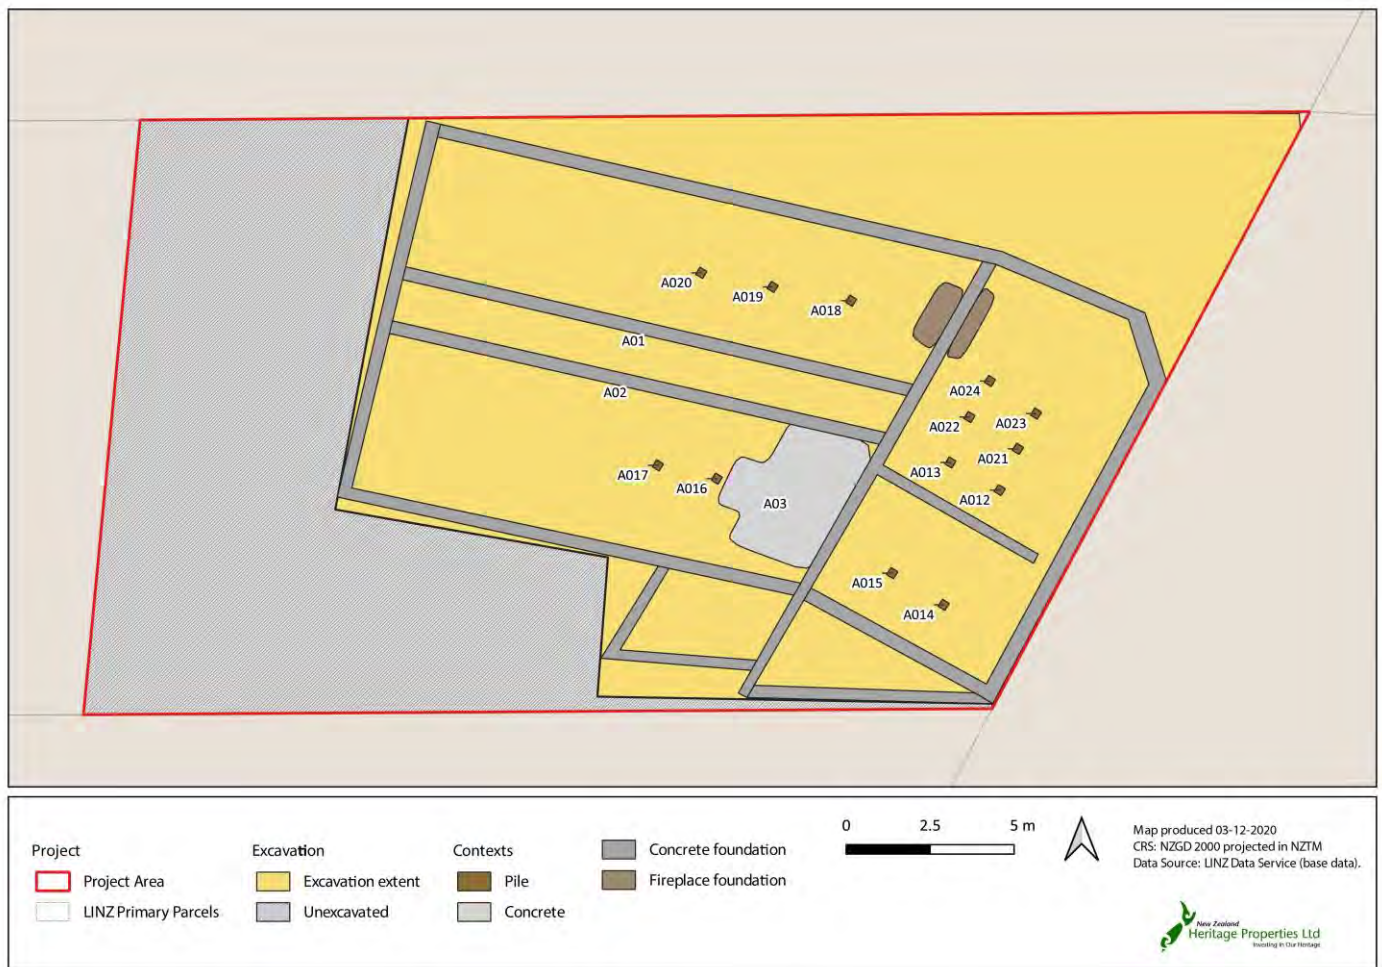
Figure 1. Site plan showing areas excavated and monitored by archaeologists from New Zealand Heritage Properties (NZHP), August 2020.

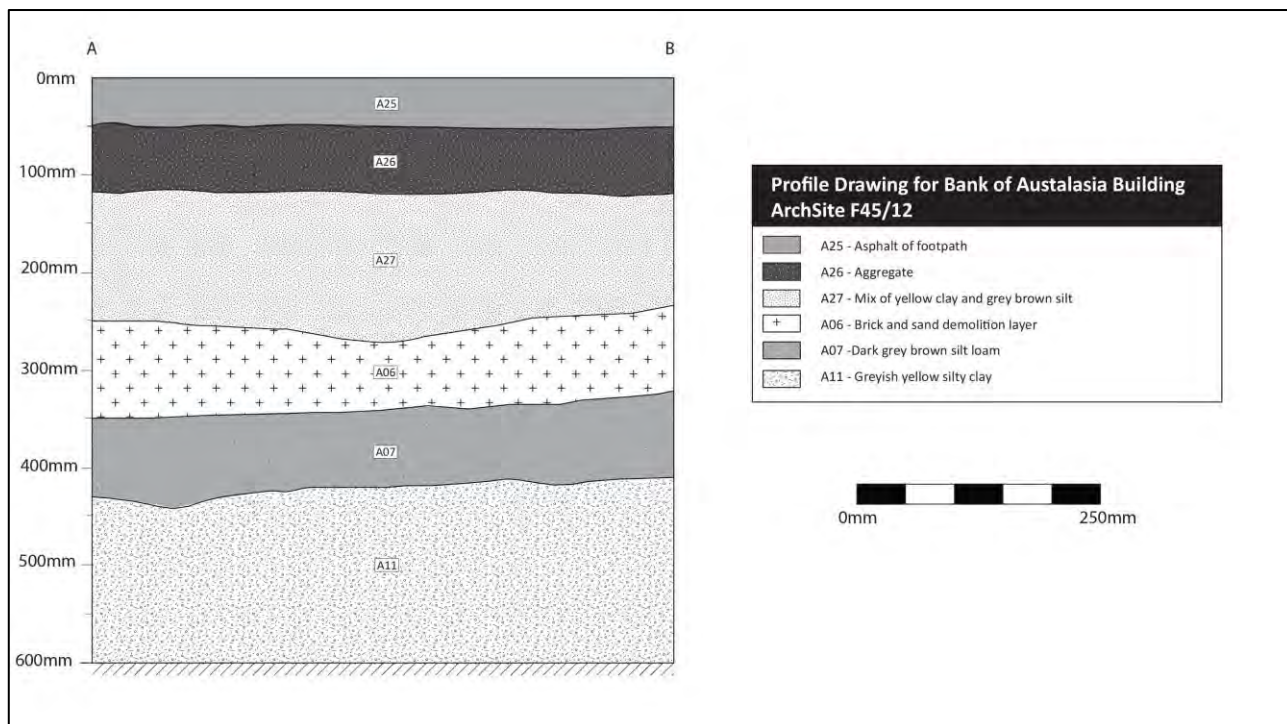
Figure 2. Stratigraphy of east baulk of Site F45/12.

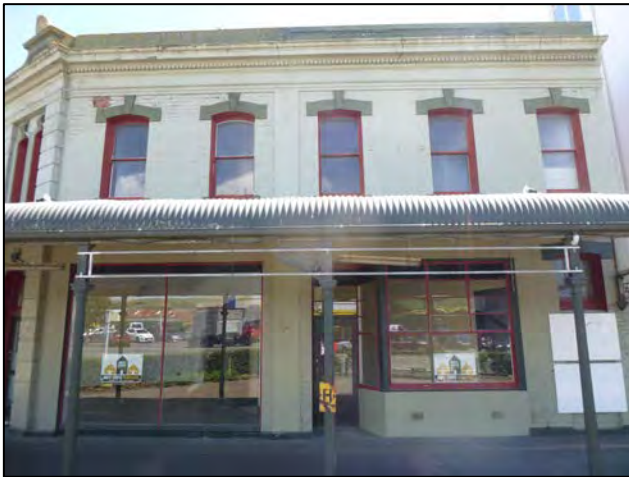
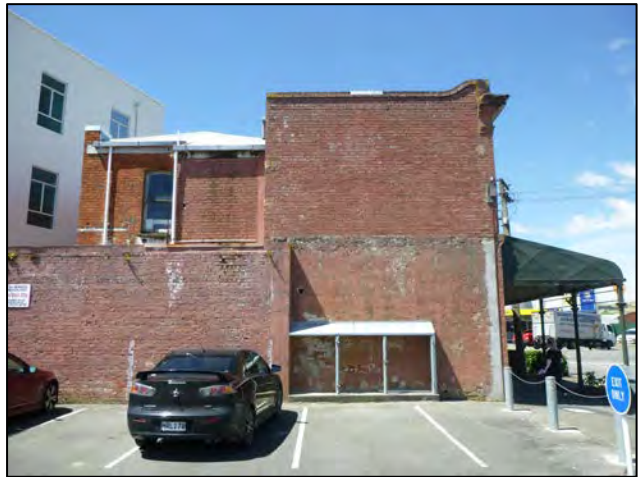
Figure 6. Left: east elevation, facing west. The three right hand windows demarcate the pre-1900 portion of the building. Right: west elevation, facing east.

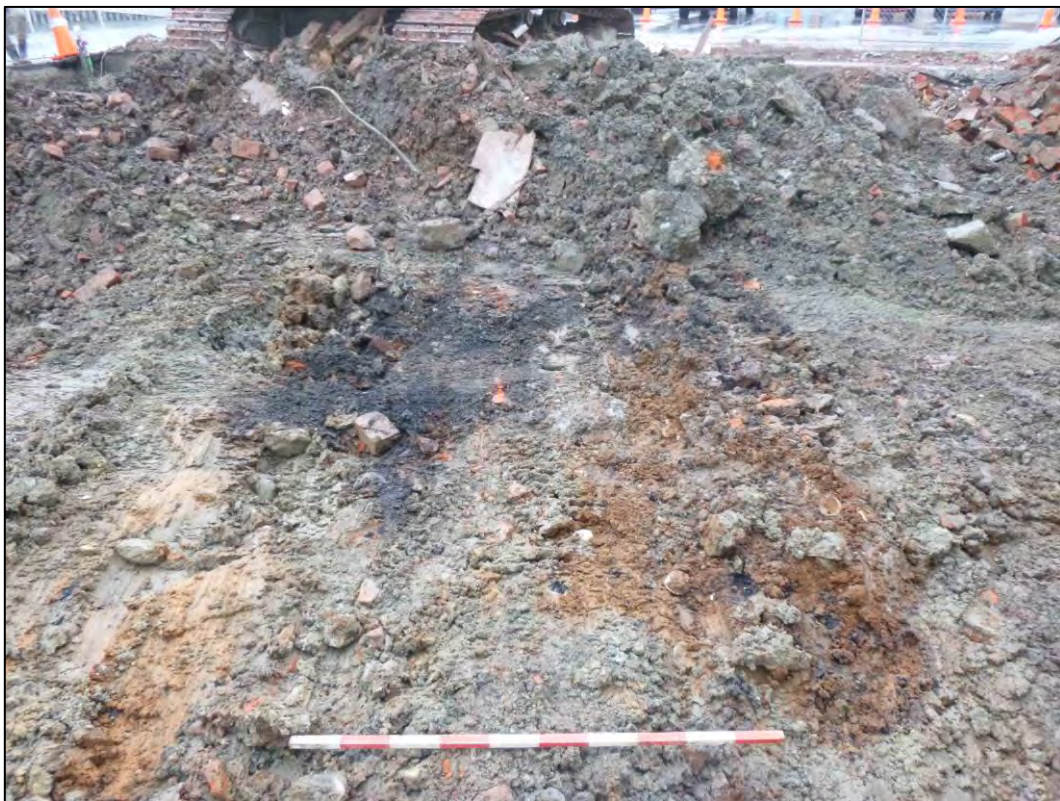
Figure 6. Smeared rubbish deposit.

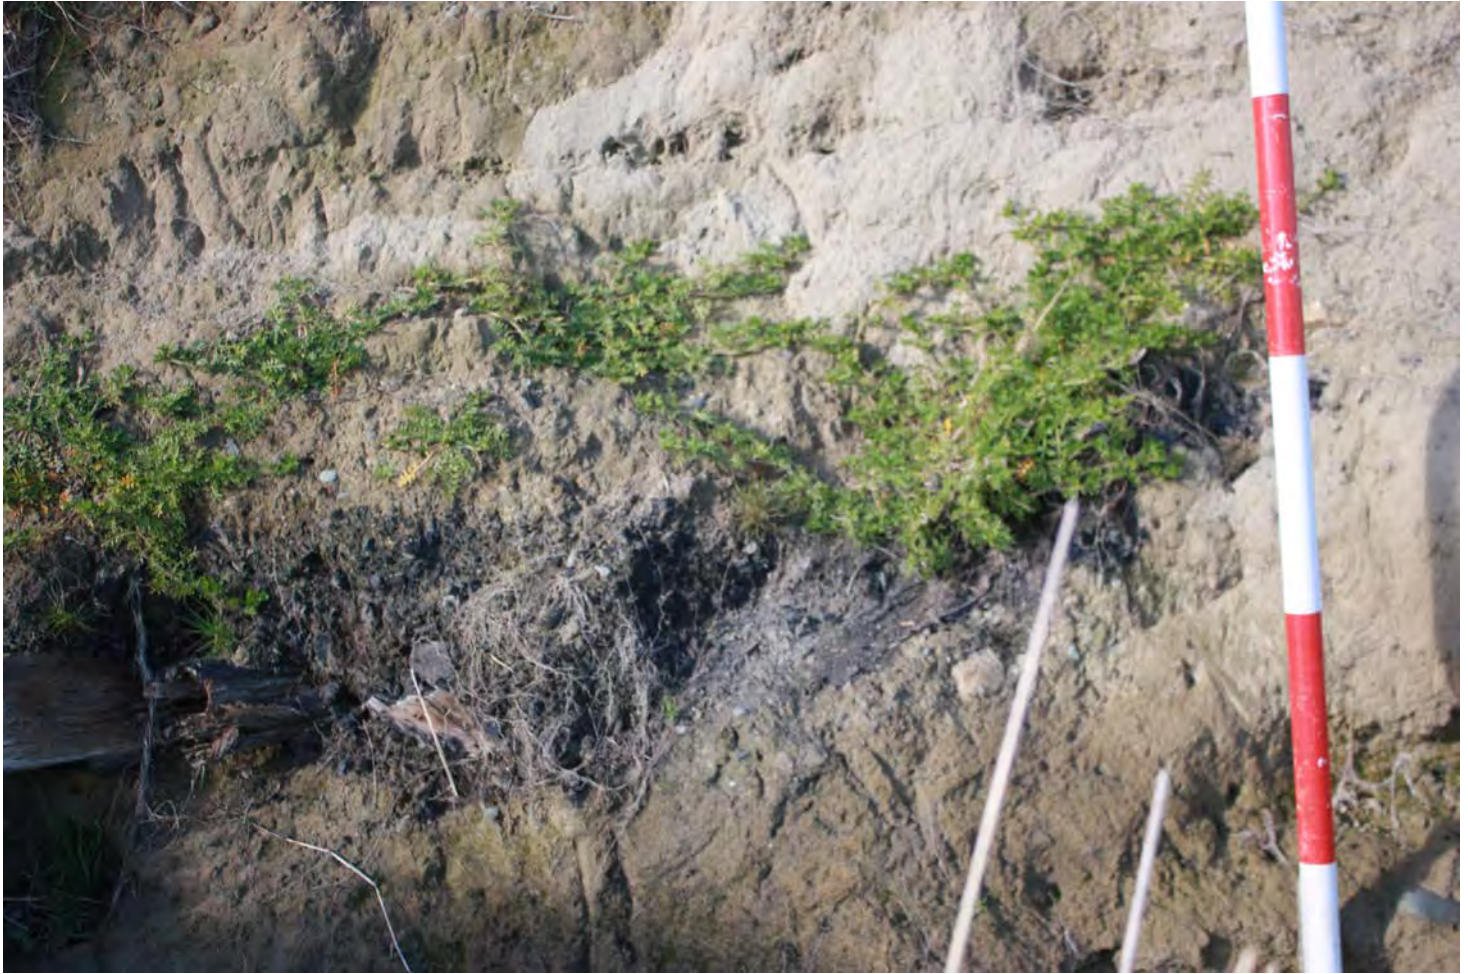
Exposed feature on east bank of the Mataura river, Nikole Wills 25 June 2020
